# Property Inspection Report

Sample Property - Richmond, TX

Date of Inspection: 8/9/2026 Time: 9:00 AM

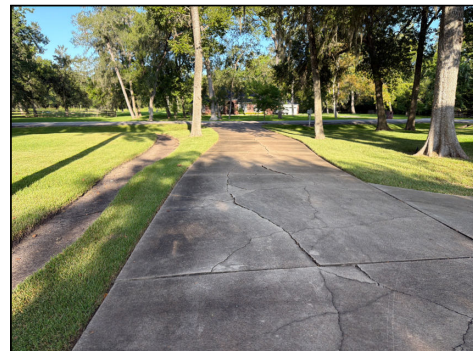
Multiple sections of the driveway observed to be cracked/broken

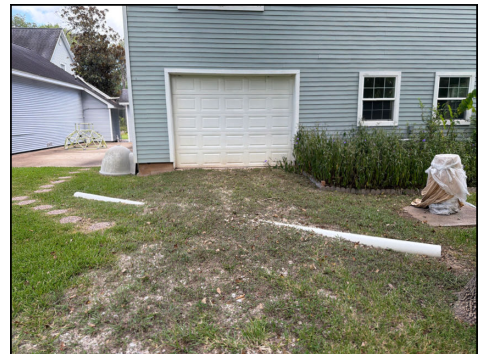
Garage downspout elbow noted to be facing the wrong direction

Grading is less than ideal at the garage apartment

Gutter extensions are recommended

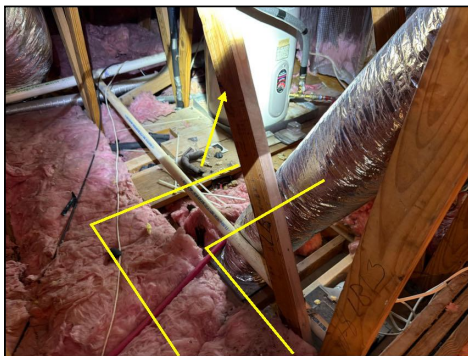
Foil sheets noted to be present in the attic/Attempt to create radiant barrier

Access to water heater does not meet current standards/No walkway

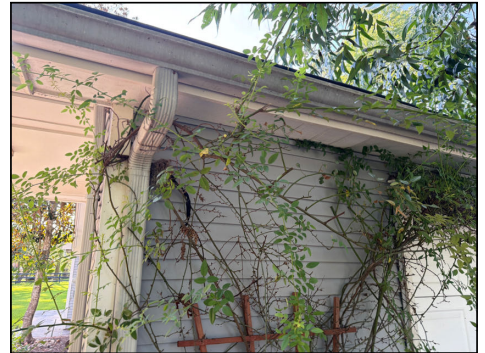
Damaged exterior paint finish from foliage growth observed

Foliage is recommended to be cut back and kept clear of the exterior walls

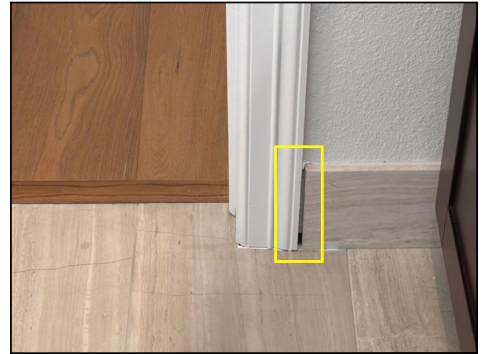
Damaged shelving observed in the primary closet

Poor quality finish observed at the primary closet door

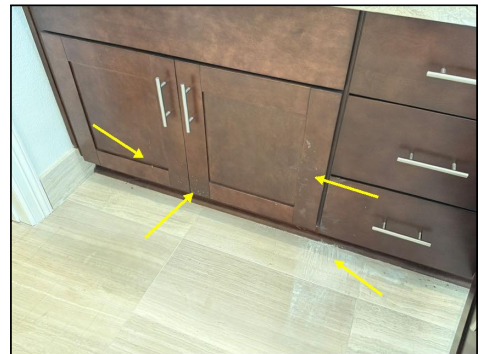
Poor quality drywall/texture finish observed at the family room high wall

What appeared to be grout residue observed on the primary bathroom cabinets

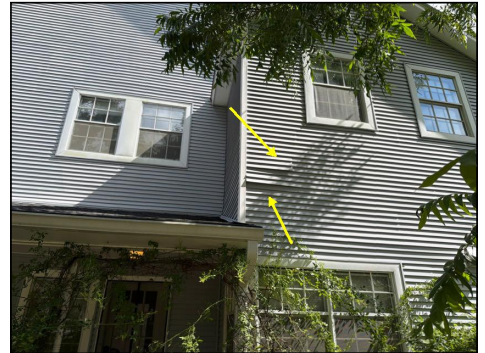
Damaged/loose siding observed on the right side of the home

Foliage should be cut back and kept clear of the exterior walls

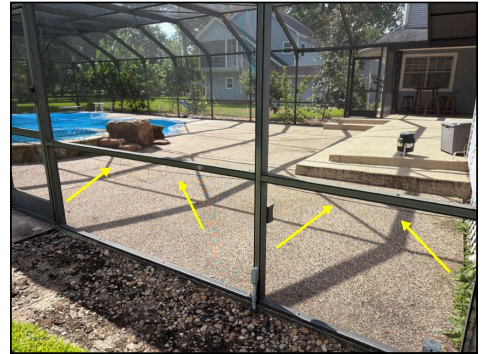
Active paper wasps observed on the left side of the home

Deteriorated screen material observed at the rear enclosure/Loose spline observed

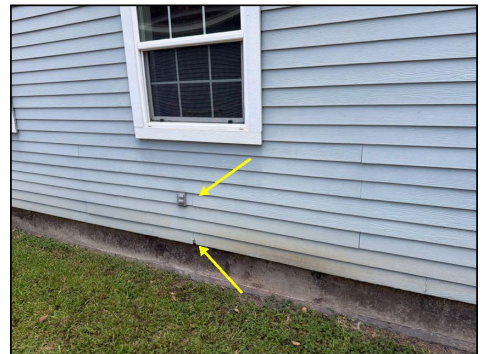
Damaged screen materials noted at the rear enclosure/Debris should be removed and kept clear

Damaged siding observed at the garage apartment

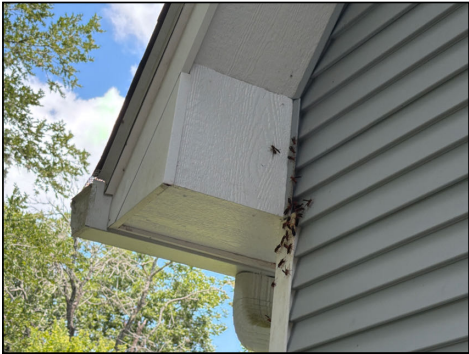
Aggressive paper wasps observed at the front left of the home/Inspector was stung walking the roof

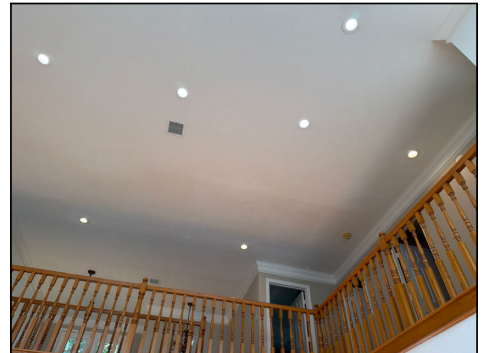
Evidence of previous repair/inconsistent finish observed at the family room ceiling

Drywall movement cracking observed at the primary bedroom ceiling

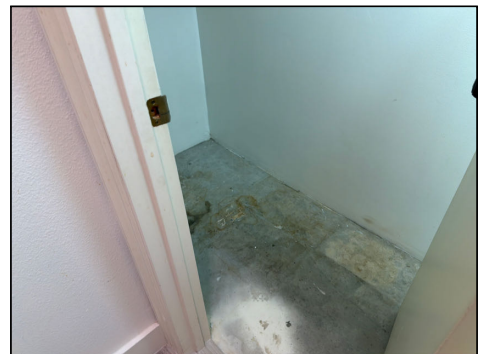
Inconsistent/incomplete paint observed at the dining room ceiling

Flooring was not present at the closet under the rear stairs

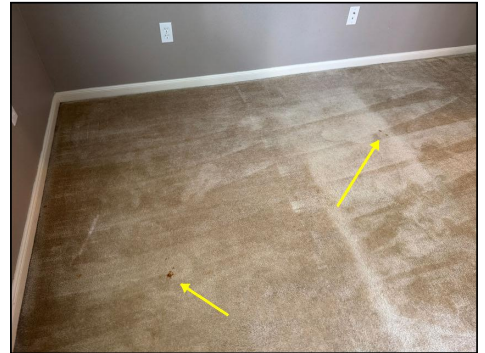
Loose carpet flooring observed at the garage apartment

Garage apartment carpet flooring observed to be stained

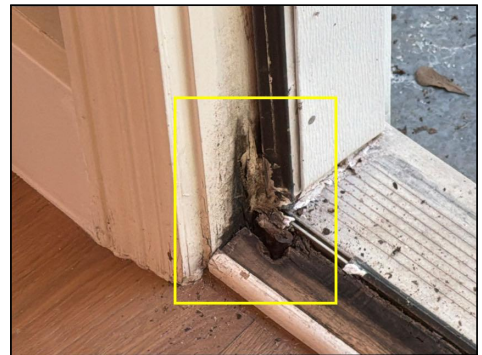
Front balcony door frame observed to be moisture damaged

- 9 Balcony-door moisture deterioration**  
 Moisture-related deterioration was present at the lower front balcony door frame, with splitting also visible at hardware attachment points. Identify and correct the water-entry source, repair flashing and sealant transitions, replace damaged materials, and evaluate concealed components when the area is opened.

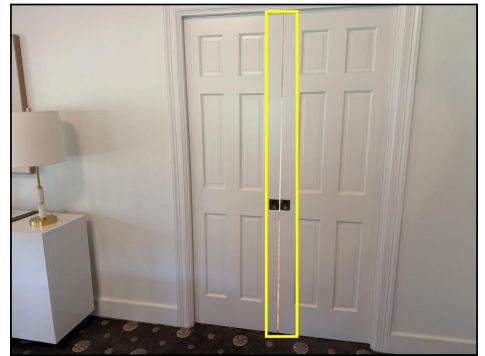
Formal living room pocket doors did not function properly

Inconsistent reveal observed at the formal living room pocket doors when closed

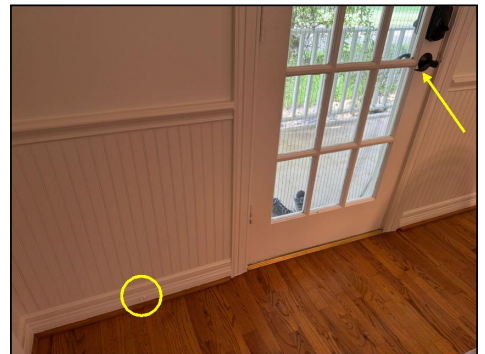
Dining room pocket doors were difficult to operate

Doorstop noted to be missing at the dining room exit/hardware is installed upside down

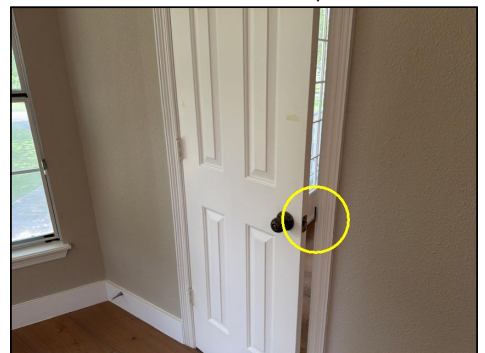
Half bathroom doorstop observed to be missing

Upstairs front right game room to balcony area door did not latch

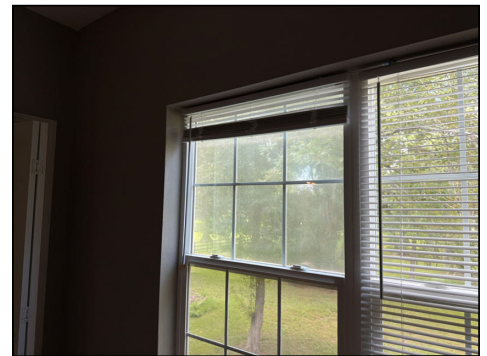
Seal failure noted at the garage apartment window

Lost seal observed at the garage apartment kitchen sink window

- Insulated-glass seal failure was observed at multiple garage-apartment windows, including the kitchen-sink window. Failed seals can cause persistent fogging, condensation, or a cloudy appearance between the panes and reduce insulating performance. Replace the affected insulated-glass units or windows as desired.

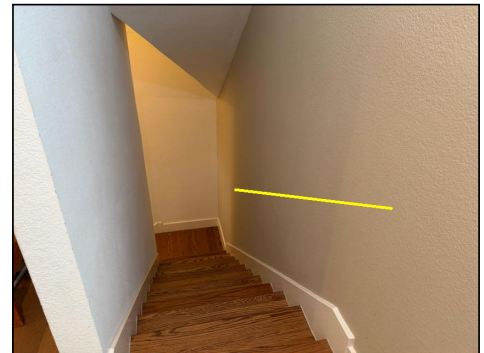
Baluster spacing does not meet current standards

Handrail noted to be missing at the rear stairs

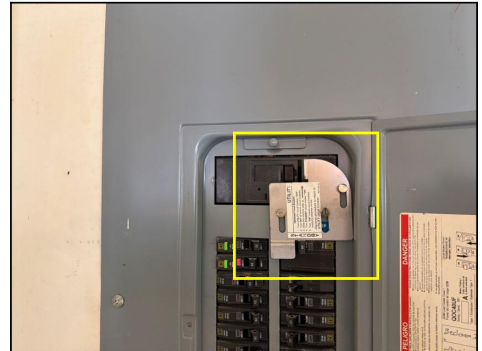
Ground and neutral wire should be separated

Generator interlock noted to be present at the garage panel

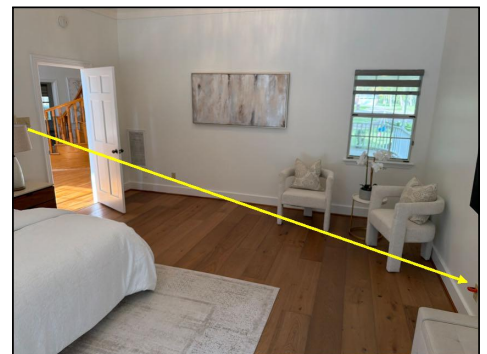
Primary bathroom outlet is not GFCI protected

Half hot switch powered outlet noted in the primary bedroom

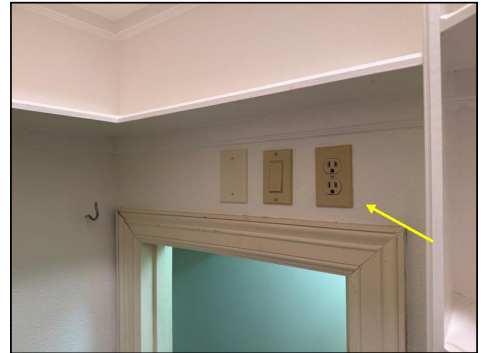
Kitchen backsplash outlet is not installed properly

Out of ordinary outlet location observed inside the kitchen pantry

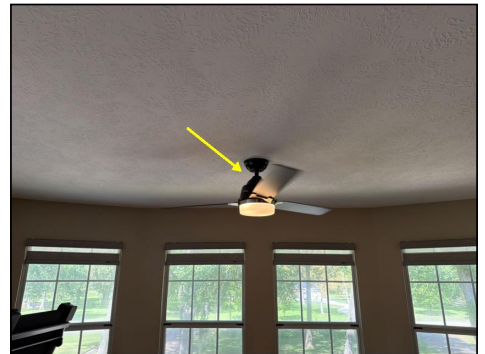
Floor plugs in the right rear game room are not flush to the floor/trip hazards

Unnecessary ceiling fan down rod noted at the front right game room/Eight foot ceiling should be flush mount

- 7 Stair, fan, and garage-door safety**  
 A handrail was missing, stair baluster spacing exceeded current safety standards, ceiling-fan downrods reduced head clearance at eight-foot ceilings, and the rear garage-door operator lacked photoelectric reverse sensors and required the wall control to be held for closing. Correct these fall, contact, and entrapment hazards.

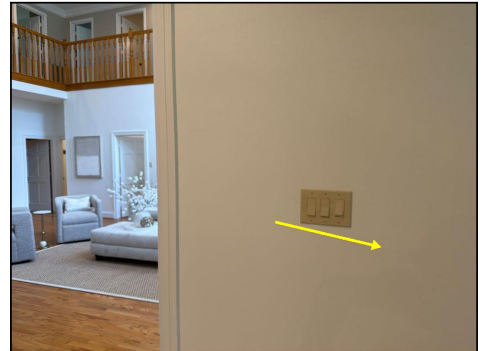
Extension cord used as permanent wiring in the attic

Crooked switches observed throughout the home

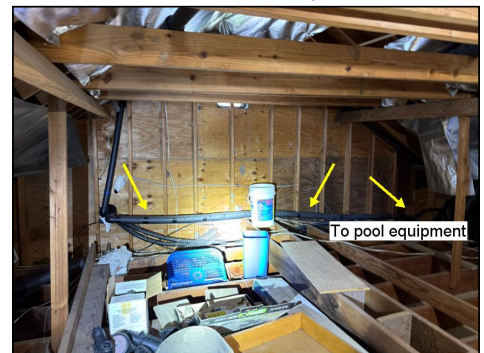
Active condensation leak/drip noted at time of inspection

Units noted to be tied into pool equipment for heat/cool transfer

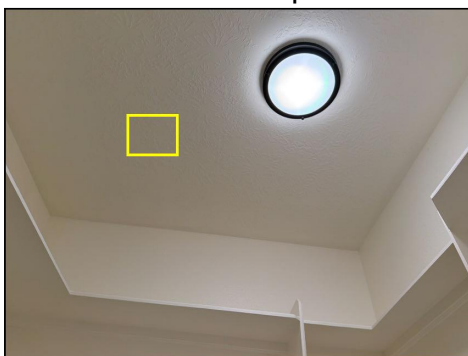
• No HVAC supply register or other means of conditioned-air distribution was observed within the kitchen pantry. Enclosed pantry spaces can experience elevated temperatures and humidity, particularly during warmer months, which can adversely affect temperature-sensitive food products such as chocolate and may contribute to less desirable storage conditions. Recommend providing an appropriately designed means of conditioned-air circulation or ventilation within the pantry to help maintain temperatures and humidity levels reasonably consistent with the conditioned interior of the home. Have a qualified HVAC professional evaluate the area and provide an appropriate supply-air or ventilation solution as needed.

Supply duct was not present inside the kitchen pantry

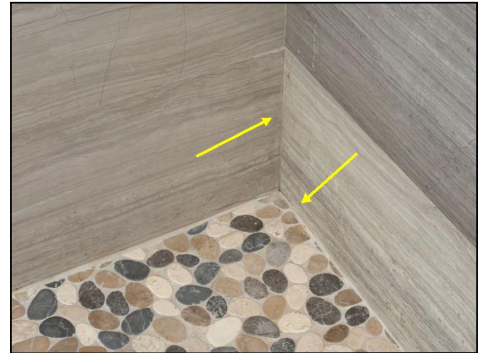
Primary bathtub is not installed properly/easily moves

Cracked grout observed at the primary shower surround

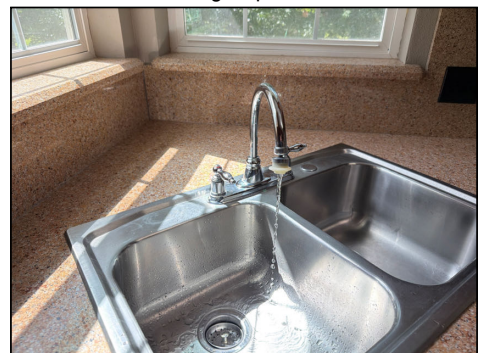
Low water pressure noted at the garage apartment fixtures

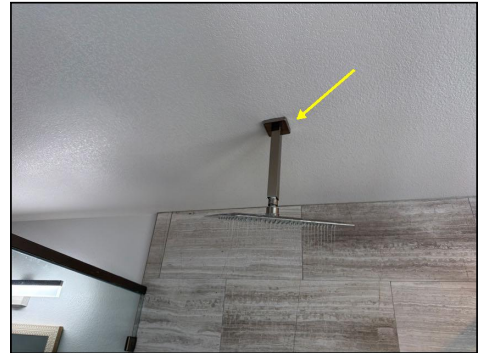
Upstairs right tub is loose at the floor/Easily moves

Upstairs right overhead shower line is loose behind the drywall

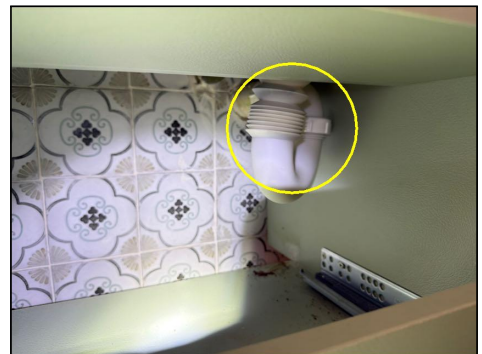
Amateur style accordion drain noted in the primary bathroom

Accordion style/amateur drain observed in the half bathroom

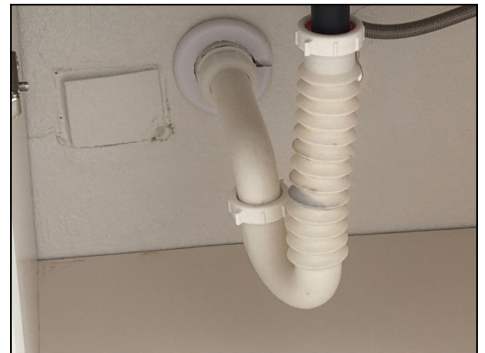
Amateur/improper drain installation at the upstairs right tub

Amateur/improper drain installation at the upstairs right vanity sink

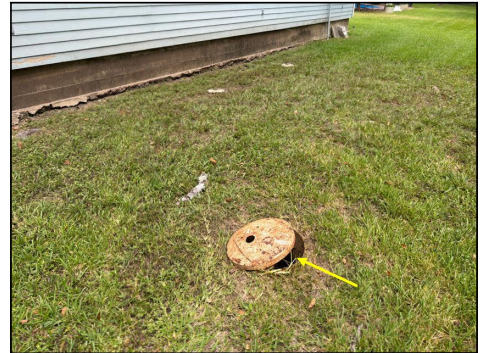
Exposed propane piping observed at the garage entry

Cover for subsurface propane tank is less than ideal/loose

- 8 Propane-system physical hazards**  
 Propane piping was exposed at the garage entry, and the subsurface tank access cover was loose. Have a qualified propane-gas professional protect the piping from impact, secure or replace the tank cover, and verify the complete system is properly installed and leak-free.

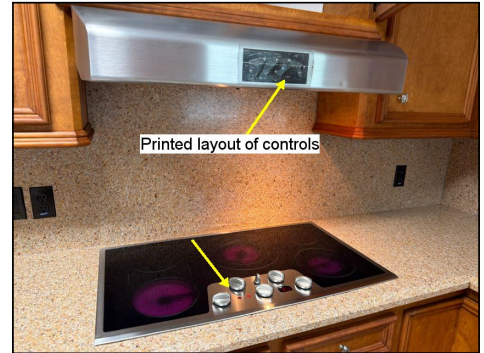
Range burners did not function properly/Did not appear to sit correctly

Controls faded at garage cooktop

- 5 Unsafe gas-range burner operation**  
 Multiple burners failed to ignite reliably and produced excessive, irregular orange flames and flare-up during testing. Do not continue operating the affected burners until a qualified appliance professional evaluates and repairs the range and verifies stable ignition and flame control.

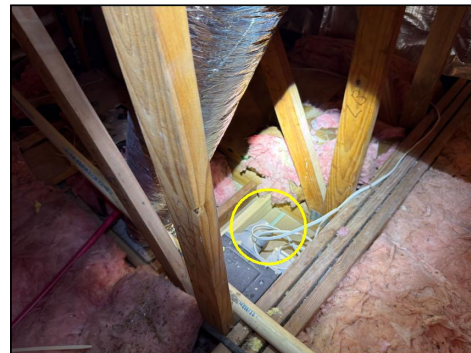
Exhaust fan in the laundry area was not present

Upstairs right bathroom fan noted to terminate in the attic
