## LIMITED INVASIVE STUCCO ASSESSMENT REPORT

Sample Address  
Houston, TX 77077

July 16, 2026

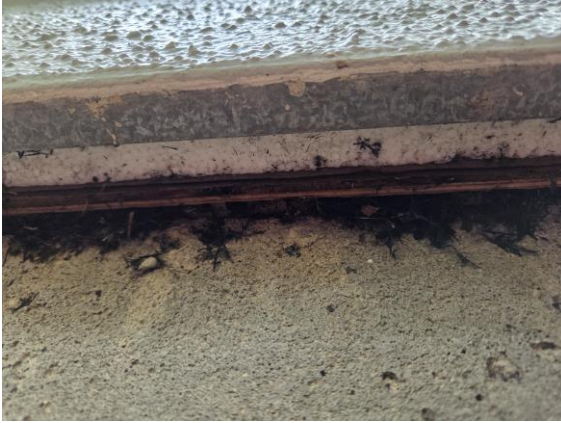
Installation consists of 3 coat/hard coat stucco, EPS (Styrofoam) and plywood. No weep screed.

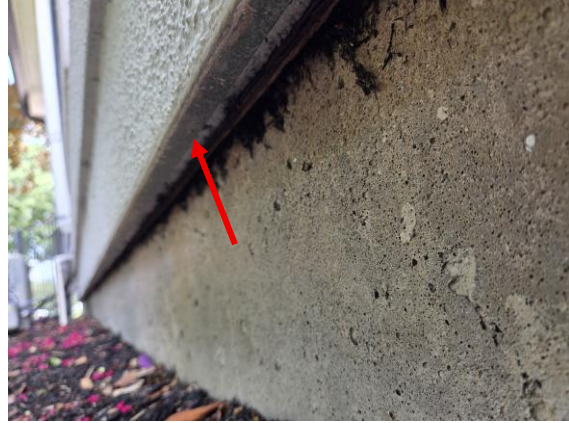
The assessment also identified several construction details that differ from current industry best practices, including the absence of perimeter weep screeds, missing kick-out flashings at roof-to-wall intersections, and limited drainage provisions beneath portions of the rear balcony. Although these conditions may increase the potential for future moisture intrusion, no evidence was observed to indicate that they are currently contributing to widespread moisture-related deterioration. These items should be addressed as part of future maintenance or when exterior repairs are performed, but they are considered secondary to the localized areas requiring further investigation.

No weep screed around entire perimeter termination.

| Priority | Recommended Action |
|---|---|
| Priority 3 – Preventive Improvements | Incorporate missing kick-out flashings, weep screeds, and improved drainage details where practical during future exterior repairs or renovations. |

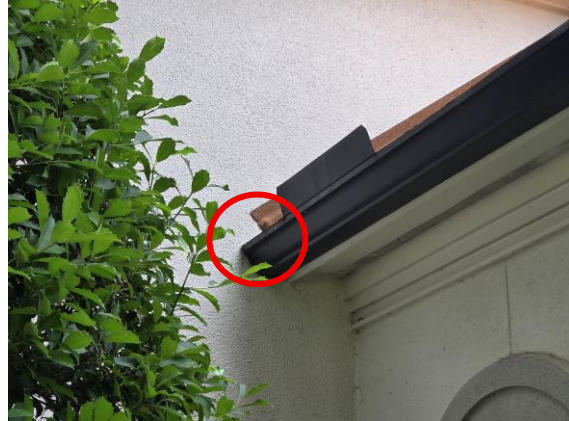
No kick out flashings present at roof to wall transitions.

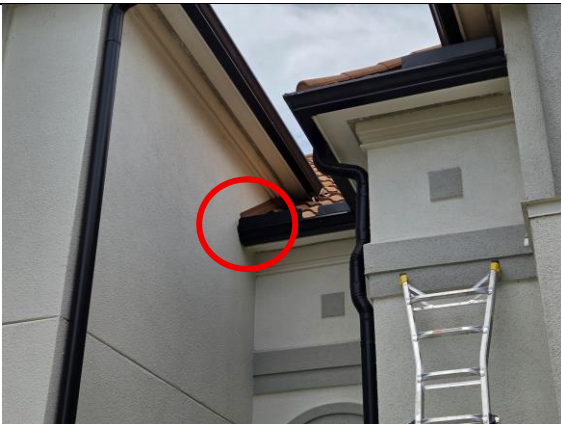
Missing kick out flashing

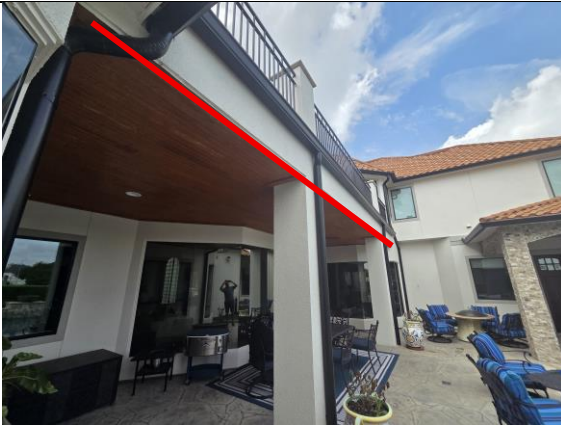
No drainage provision under rear balcony soffit.  
NOTE: No elevated moisture readings in area.

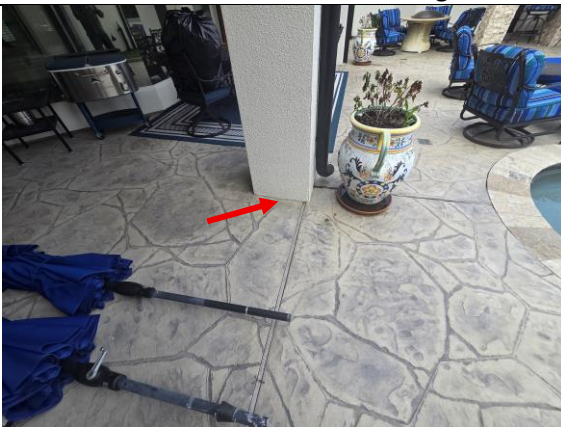
| ND=Not Determined NA=Not Applicable | Yes | No | ND | NA | Comments: |
|---|---|---|---|---|---|
| Stucco adequate clearance ground: | <input type="checkbox"/> | <input checked="" type="checkbox"/> | <input type="checkbox"/> | <input type="checkbox"/> | Inadequate at rear balcony columns |

Inadequate clearance/drainage at columns.

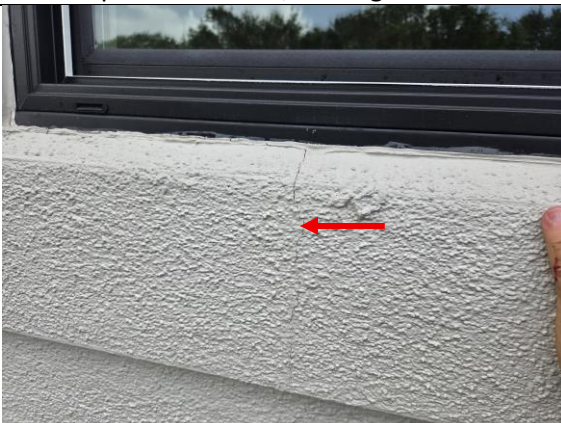
| ND=Not Determined NA=Not Applicable | Yes | No | ND | NA | Comments: |
|---|---|---|---|---|---|
| Visible stucco damage or cracking: | <input checked="" type="checkbox"/> | <input type="checkbox"/> | <input type="checkbox"/> | <input type="checkbox"/> | Very minor – left elevation window trim |

Minor crack at left elevation trim band.

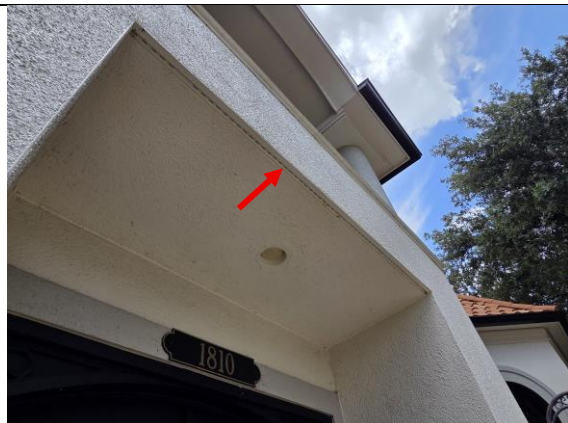
NOTE: The front entry soffit has drainage provision.

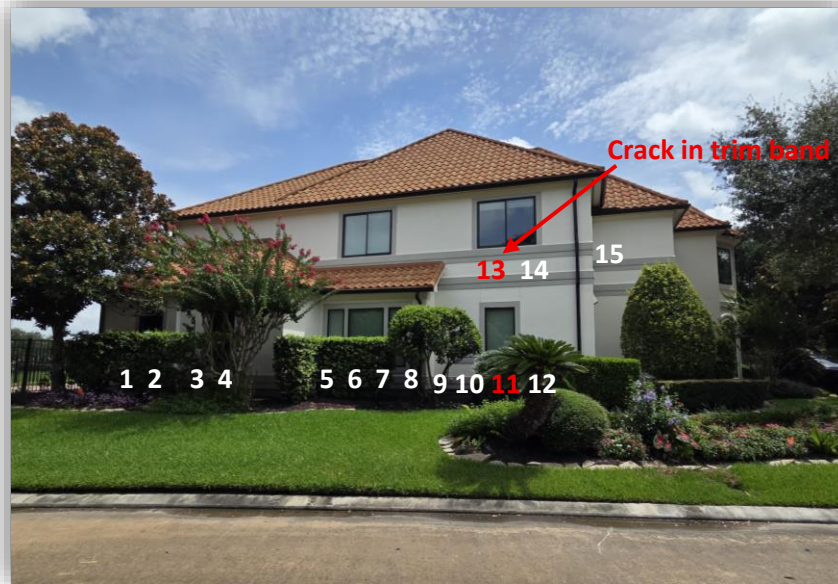
## Test Location: Left Elevation

| Location | Moisture Reading | Substrate Condition | Remarks: |
|---|---|---|---|
| 1 | 25.2% | Firm | No loss of substrate integrity or readily apparent deficiencies at the associated window assembly were observed. |
| 11 | NA | NA | <b>Substrate appears compromised – CORE TEST RECOMMENDED.</b> |
| 13 | NA | NA | <b>Substrate appears compromised – CORE TEST RECOMMENDED.</b> |
| 14 | 32.3% | Firm | No loss of substrate integrity or readily apparent window deficiencies noted. |
| 15 | 13.6% | Firm | No kick out flashing present. |
| <b>Comments:</b><br>Elevated moisture may indicate active or intermittent moisture intrusion requiring further evaluation in conjunction with other report findings. | | | |

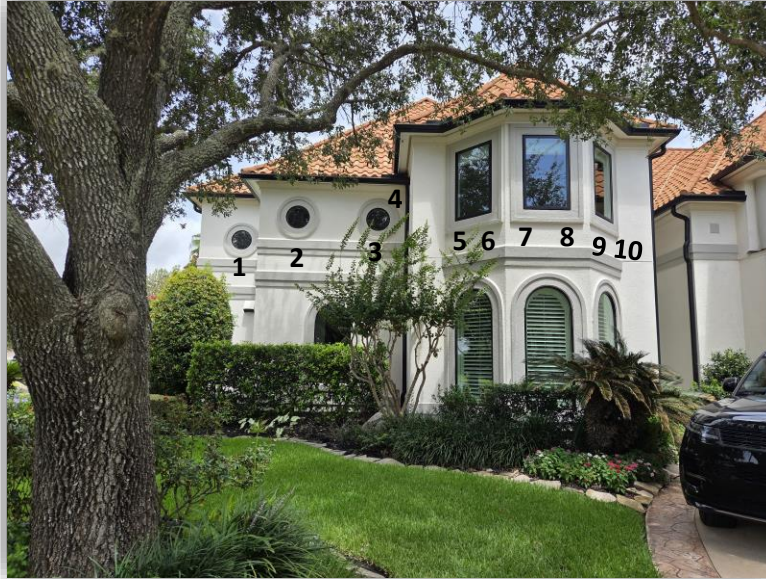
## Test Location: Front Left Elevation

| Location | Moisture Reading | Substrate Condition | Remarks: |
|---|---|---|---|
| 4 | 12.9% | Firm | No kick out flashing present. |
| <b>Comments:</b><br>Elevated moisture may indicate active or intermittent moisture intrusion requiring further evaluation in conjunction with other report findings.<br><br>Missing Kickout Flashings: Although no elevated moisture or substrate deterioration was identified below at the time of inspection, the absence of kick-out flashing can increase the potential for future moisture intrusion. | | | |

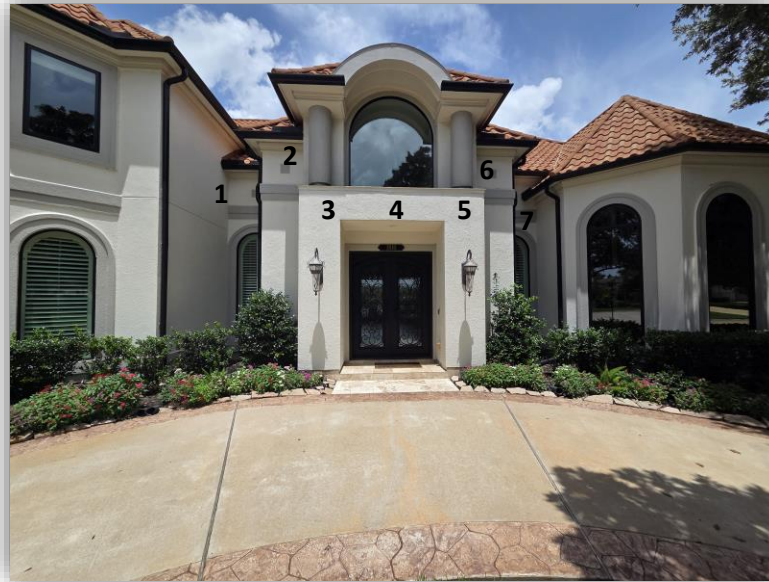
## Test Location: Front Middle Elevation

| Location | Moisture Reading | Substrate Condition | Remarks: |
|---|---|---|---|
| 1 | 13.3% | Firm | No kick out flashing present |

Probe testing beneath the lower-level windows was not performed due to the trim band and the limited wall area (approximately 6 inches) below it. However, the exposed substrate was visually inspected and manually evaluated, and appeared sound with no apparent deterioration.

Missing Kickout Flashings: Although no elevated moisture or substrate deterioration was identified below at the time of inspection, the absence of kick-out flashing can increase the potential for future moisture intrusion.

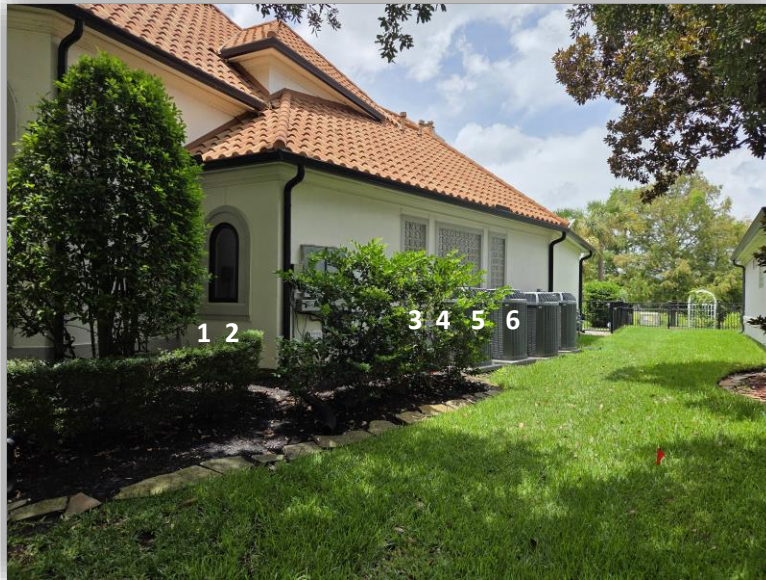
## Test Location: Right Elevation

| Location | Moisture Reading | Substrate Condition | Remarks: |
|---|---|---|---|
| 1 | 12.0% | Firm | No loss of substrate integrity or readily apparent deficiencies at the associated window assembly were observed. |

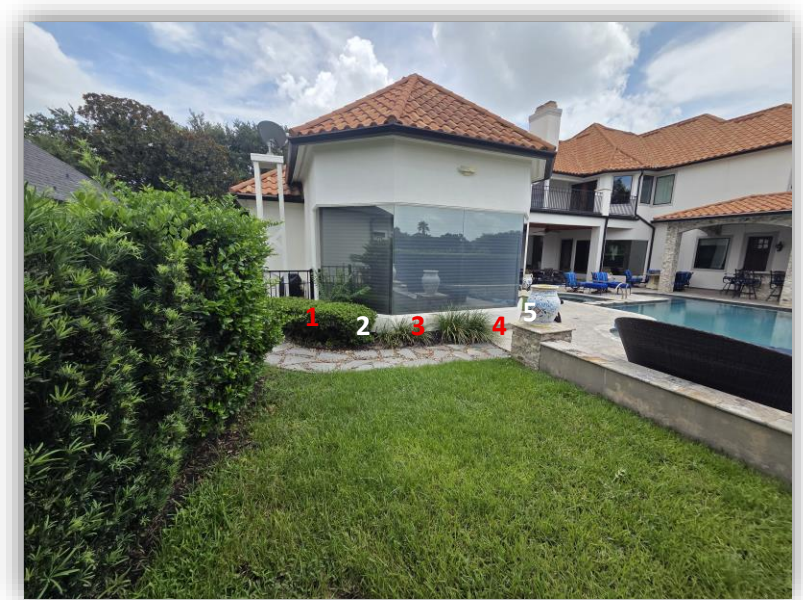
## Test Location: Rear Right Elevation

| Location | Moisture Reading | Substrate Condition | Remarks: |
|---|---|---|---|
| 1 | NA | NA | <b>Substrate appears compromised – CORE TEST RECOMMENDED.</b> |
| 3 | NA | NA | <b>Substrate appears compromised – CORE TEST RECOMMENDED.</b> |
| 4 | NA | NA | <b>Substrate appears compromised – CORE TEST RECOMMENDED.</b> |

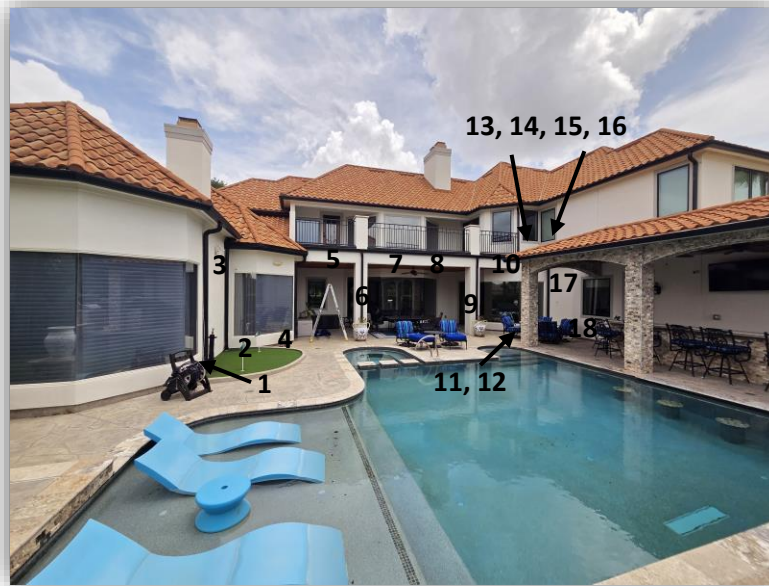
## Test Location: Rear Middle Elevation

| Location | Moisture Reading | Substrate Condition | Remarks: |
|---|---|---|---|
| 3 | 13.7% | Firm | No kick out flashing present. |
| 6 | NA | NA | See comments below |
| 9 | NA | NA | See comments below |

*Comments:* When testing the balcony columns, the probe advanced through the stucco without contacting a solid substrate. While no evidence of moisture intrusion was identified at the balcony above, this atypical finding may be indicative of an unbacked stucco application or localized substrate deterioration. Destructive evaluation would be required to determine the exact condition.

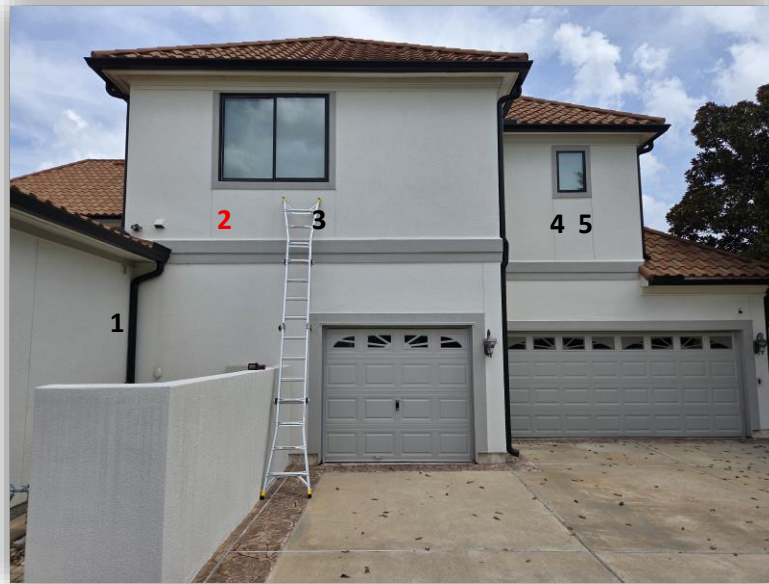
## Test Location: Rear Left Elevation

| Location | Moisture Reading | Substrate Condition | Remarks: |
|---|---|---|---|
| 1 | 12.0% | | No kick out flashing present. See comment below. |
| 2 | NA | NA | <b>Substrate appears compromised – CORE TEST RECOMMENDED.</b> |
| <b>Comments:</b><br>Missing Kickout Flashings: Although no elevated moisture or substrate deterioration was identified below at the time of inspection, the absence of kick-out flashing can increase the potential for future moisture intrusion. | | | |
