# Property Inspection Report

Sample Property - Richmond, TX

Date of Inspection: 8/9/2026 Time: 9:00 AM

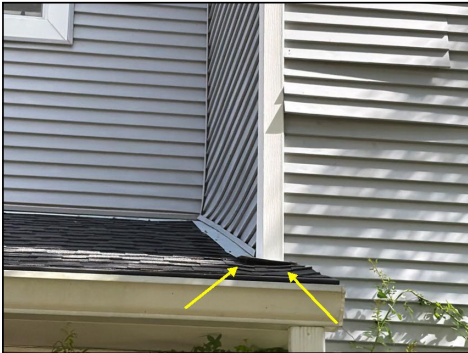
Raised flashing observed on the right side of the home

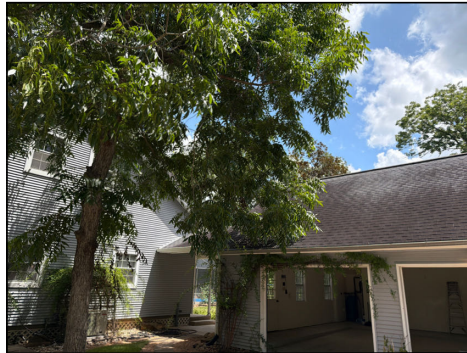
Tree branches should be cut back and kept clear of the roofing materials

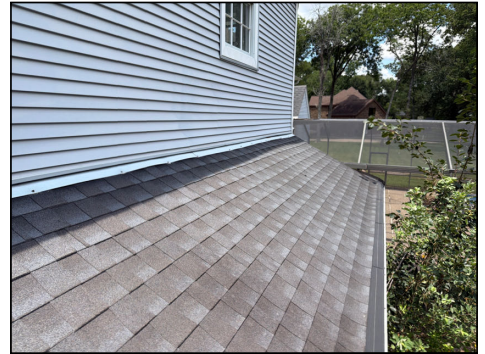
Roofing materials appeared to be performing as intended

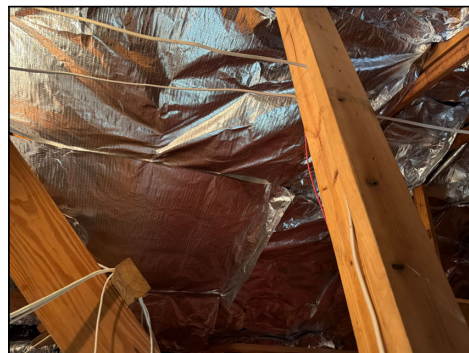
Foil sheets noted to be present in the attic/Attempt to create radiant barrier

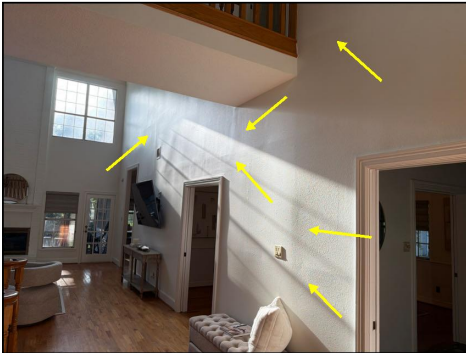
Nearly every drywall seam visible at the family room wall with bright sunlight illuminating

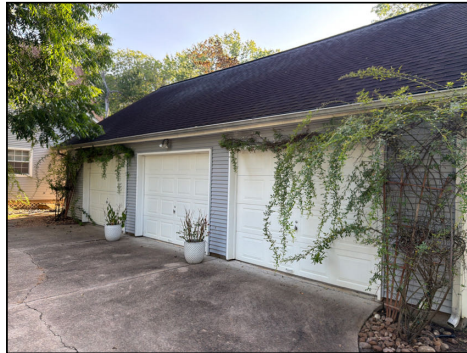
Foliage is recommended to be cut back and kept clear of the exterior walls

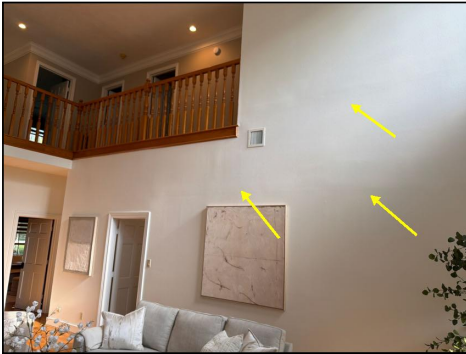
Poor drywall finish/visible seams observed at the family room

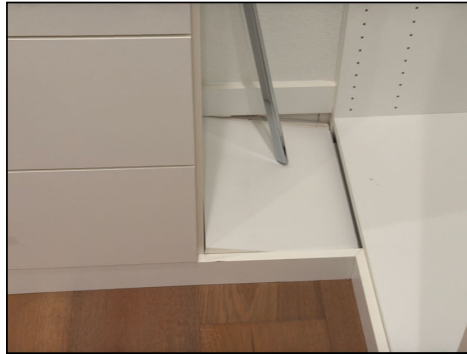
Damaged shelving observed in the primary closet

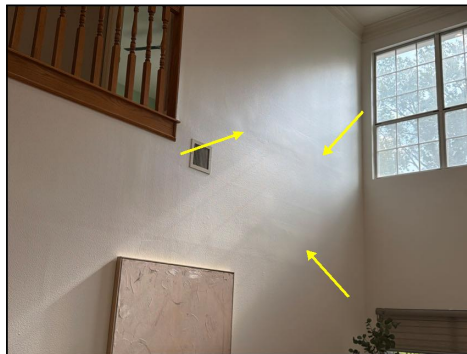
Poor quality drywall/texture finish observed at the family room high wall

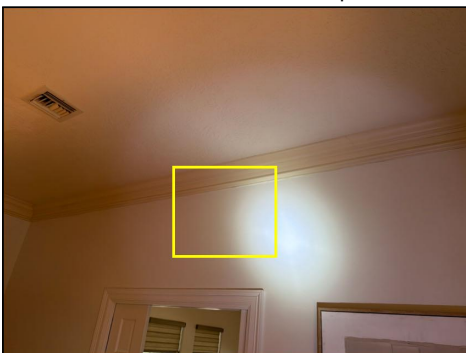
Poor quality drywall finish observed at the dining room wall

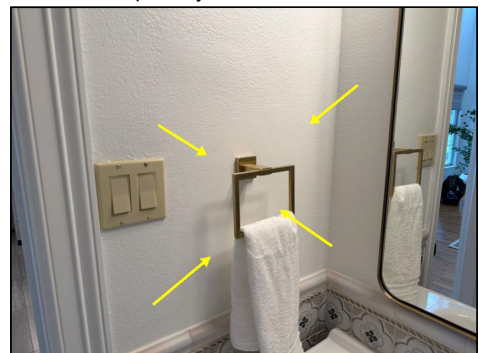
Missing/inconsistent wall texture observed in the half bathroom

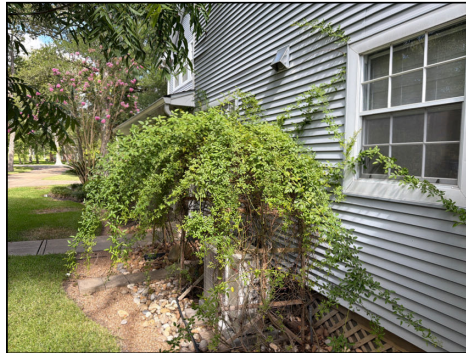
Foliage should be cut back and kept clear of the exterior walls

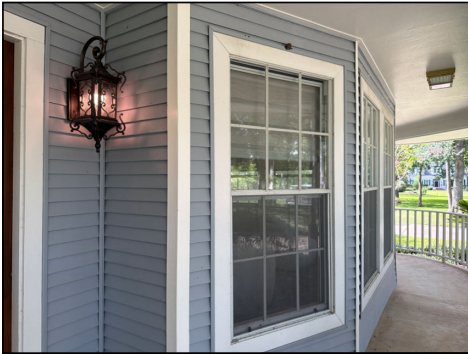
Exterior walls noted to be dirty around the perimeter of the home

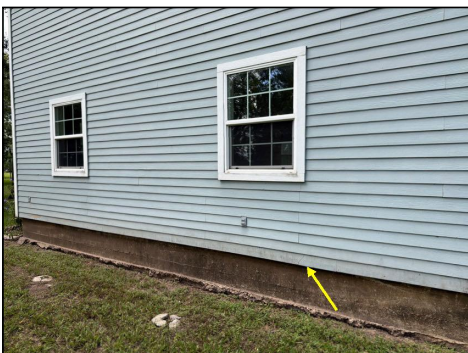
Damaged siding observed at the garage apartment

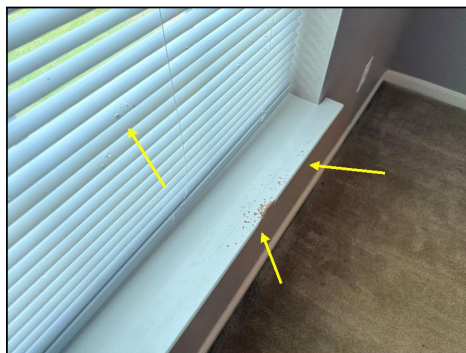
Damaged window stool trim observed at the garage apartment

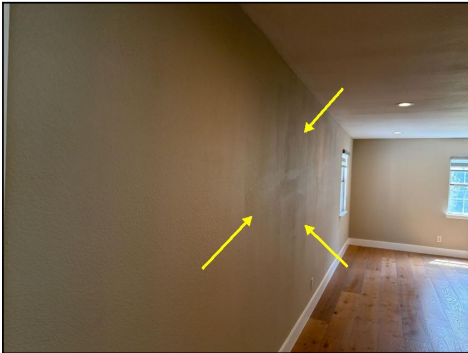
Poor quality drywall/paint finish observed at the upstairs right rear room

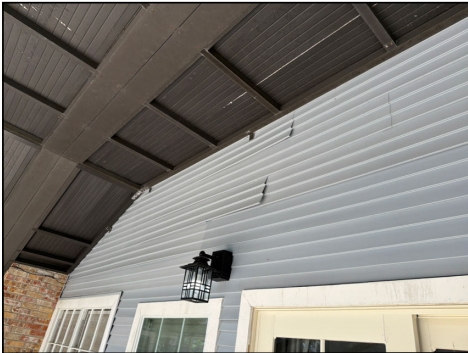
Loose/damaged siding noted at the rear of the home

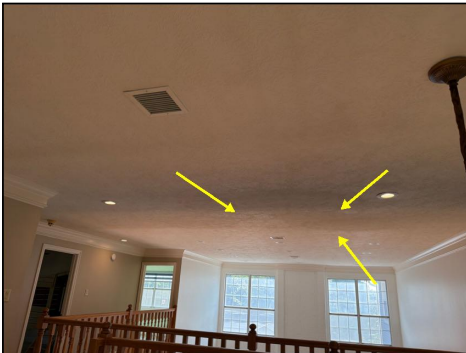
- Inconsistent ceiling texture, finish, and coloration were observed above the stair overlook at the family room. The irregular appearance is consistent with an area that may have been previously repaired or refinished following a moisture-related event. The original source and extent of any previous moisture intrusion could not be determined during the inspection. No representation can be made regarding concealed conditions based solely on the finished surface. The buyer should obtain information regarding any previous leakage or repairs in this area and monitor for recurrence. If moisture staining or other evidence of active leakage develops, further evaluation should be performed to identify and correct the source.

Inconsistent finish/evidence of previous repairs observed at the ceiling above the family room

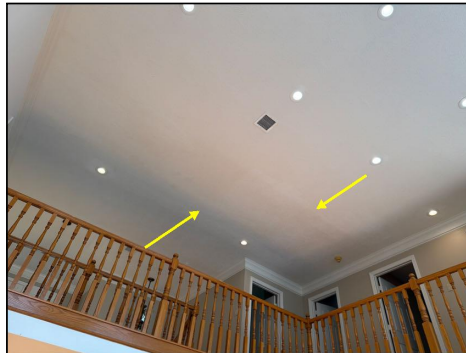
Evidence of previous repair/inconsistent finish observed at the family room ceiling

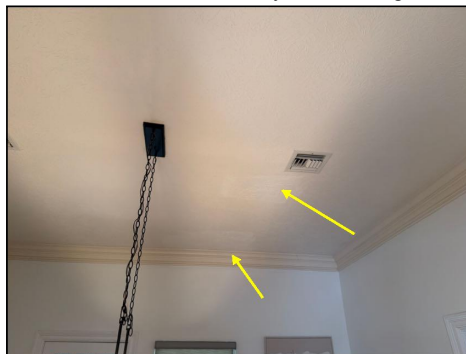
- Inconsistent and incomplete paint coverage was observed at portions of the dining room ceiling, resulting in visible variations in color, sheen, and overall finish. The affected areas have an unfinished appearance and are inconsistent with a properly completed painted surface. Properly prepare the affected ceiling surfaces and apply additional paint as needed to provide uniform coverage, color, sheen, and a consistent professional finish.

Inconsistent/incomplete paint observed at the dining room ceiling

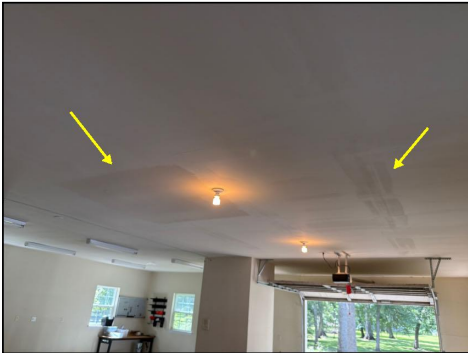
Inconsistent paint observed at the rear garage ceiling

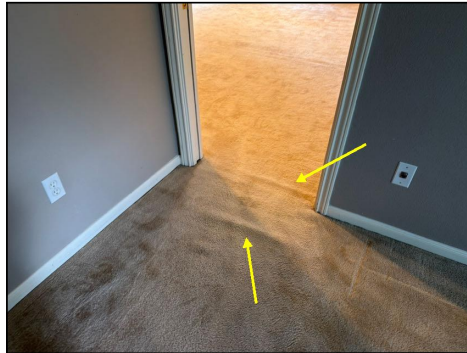
Loose carpet flooring observed at the garage apartment

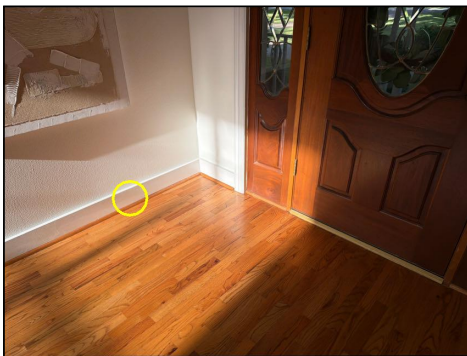
Front entry doorstop observed to be missing

- Doorstops were missing at various interior doors. Install doorstops where needed to prevent door hardware from contacting and damaging adjacent walls and finishes.

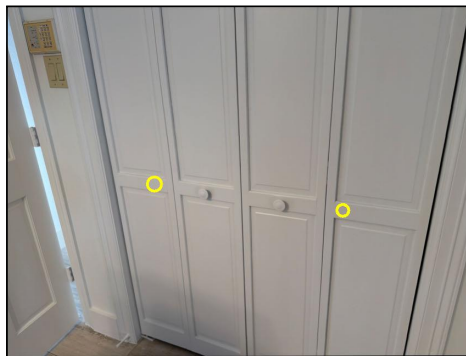
Hardware at the breakfast area closet doors is not installed properly

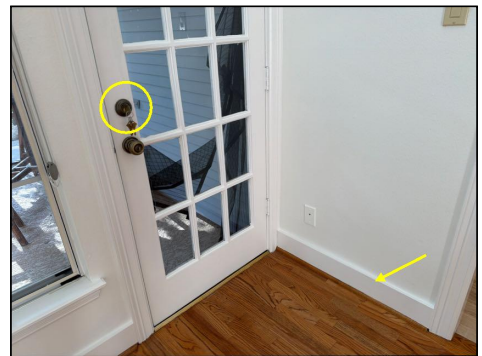
Family room exit doorstop noted to be missing/Keyless locks are required on exit doors

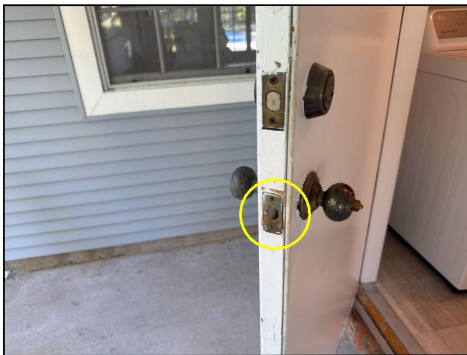
- Exterior door hardware did not function properly at the laundry exit, and the upstairs front-right game-room door to the balcony did not latch when closed. Exterior doors should operate smoothly, latch securely, and allow reliable emergency egress. Repair or adjust the affected doors, latches, and hardware and verify proper operation and security.

Laundry exit door hardware did not function properly

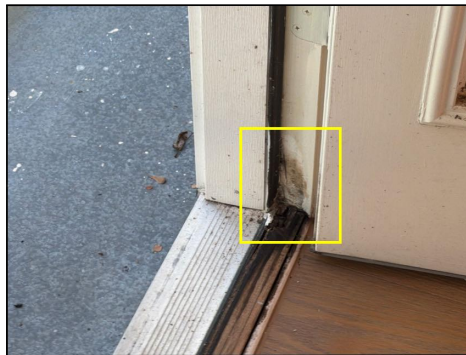
- Keyless locks are required on exterior doors for emergency egress.
- Moisture-related damage and deterioration were observed at the lower portions of the door frame on both the right and left sides of the front balcony door, consistent with water penetration at this area. Continued water entry can result in progressive deterioration of the door frame and potentially affect concealed wall, sheathing, or framing components. The source of water penetration should be identified and corrected, including evaluation of the door installation, flashing, sealant, threshold, and surrounding exterior transitions. Repair or replace damaged materials and evaluate concealed components for additional moisture-related deterioration when the area is opened for repairs.

Front balcony door frame observed to be moisture damaged

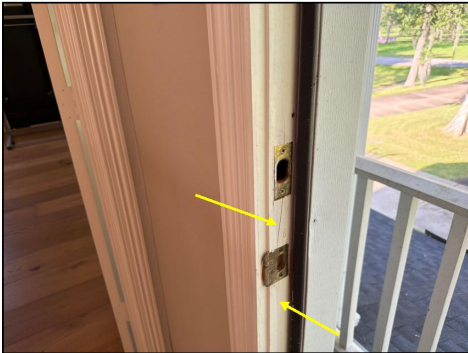
- The front balcony door frame was observed to be split and cracked at the attachment points for the door hardware. The damage appears consistent with the mounting screws having been driven into the wood without adequate pilot holes, causing the wood to split around the fasteners. Splitting at hardware attachment points can weaken the connection, allow the hardware to loosen over time, and interfere with proper door operation and security. Repair or replace the damaged portions of the door frame and properly reinstall and secure the hardware using appropriate installation methods to provide a solid and durable attachment.

Front balcony door frame observed to be damaged/split

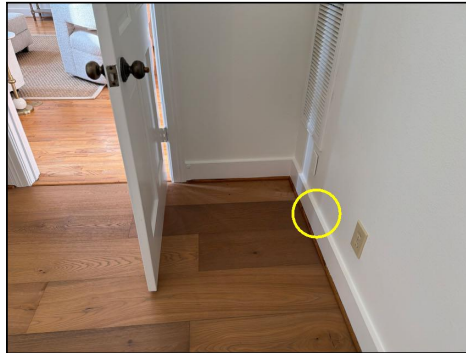
Primary bedroom doorstop noted to be missing

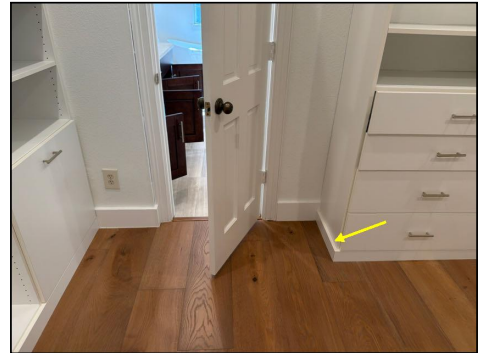
Primary closet doorstop noted to be missing

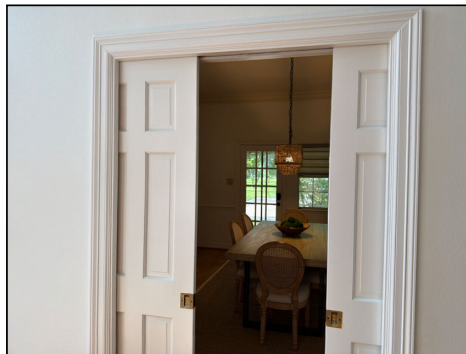
- The pocket doors at the formal living and dining room were difficult to operate and required excessive effort to fully close. When closed, the doors did not align evenly with one another and an inconsistent reveal was present from the top to the bottom where the doors meet. This condition may be related to adjustment of the door hardware, worn or damaged rollers/tracks, or movement/misalignment of the door assemblies over time. Have the pocket door assemblies evaluated and adjusted or repaired as needed to provide smooth operation, proper alignment, and a consistent finished appearance when closed.

Dining room pocket doors were difficult to operate

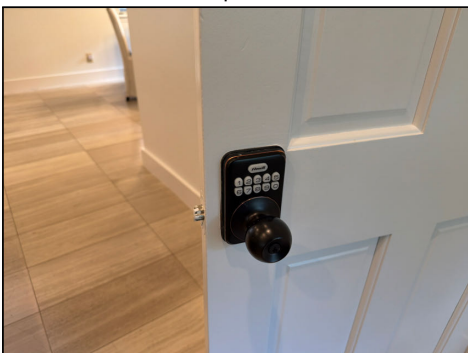
- A keypad/combination lock was installed on the kitchen pantry door. This is an unconventional installation for an interior pantry and may restrict access if the combination is unavailable or the hardware malfunctions. Obtain the operating code and instructions, verify reliable operation, and remove or replace the lock as desired.

Out of ordinary key lock/combination door hardware observed at the kitchen pantry

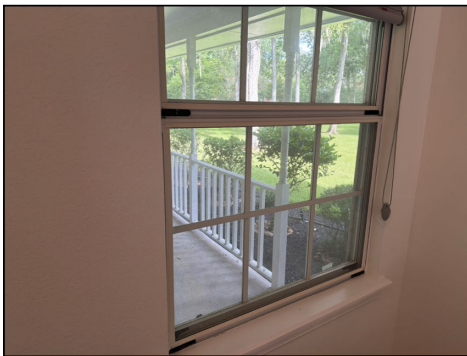
- Windows that were stuck shut or hard to open were encountered throughout the home during the inspection. All of the operable windows are recommended to be lubricated and or adjusted to prevent damage to the tension springs.

Interior primary bedroom window would not open

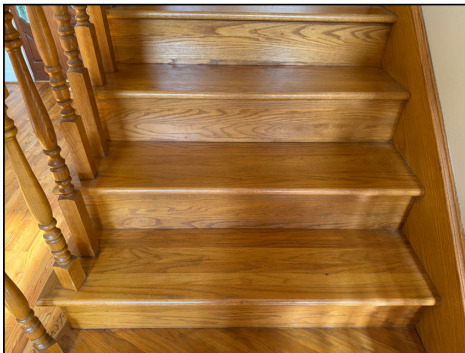
- Typical squeaks and movement-related pops were present when the stairways were used. These sounds are common as wood stair components age and move against adjoining materials. Secure accessible stair components and make repairs as desired if the noise is objectionable or movement increases.
- Baluster spacing exceeds the maximum 4-inch requirement.
- **Handrails are missing at one or more locations and should be installed as required.**

Typical squeaks and pops noted at the stairs

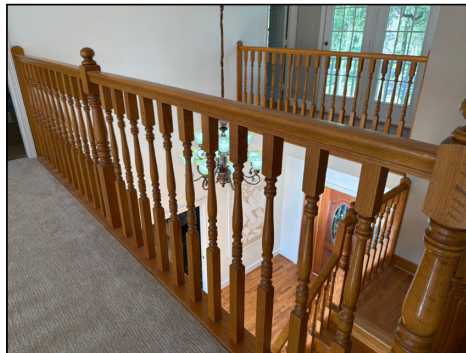
Baluster spacing does not meet current standards

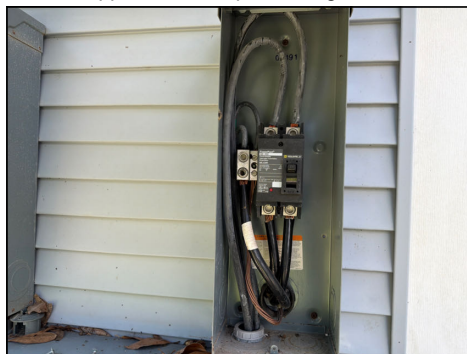
Panel appeared to be performing as intended

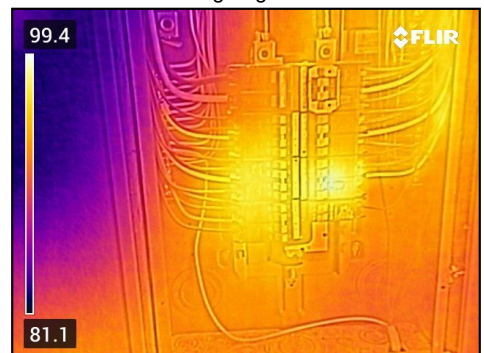
Panel appeared to be performing as intended

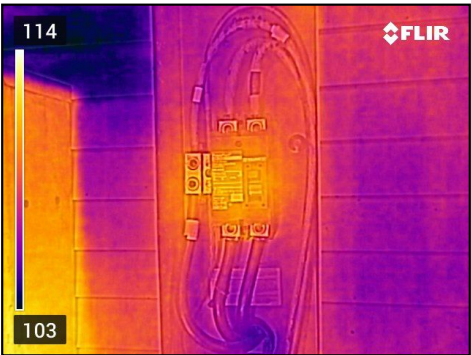
Panel appeared to be performing as intended

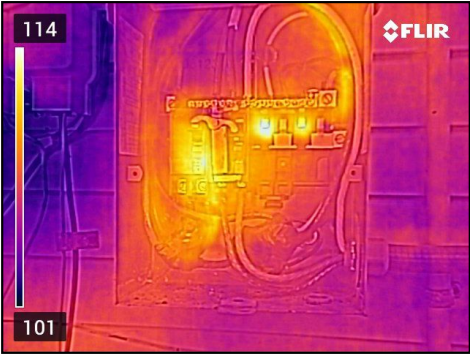
Panel appeared to be performing as intended

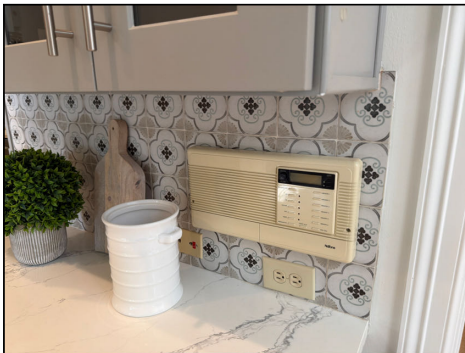
Intercom system was not inspected

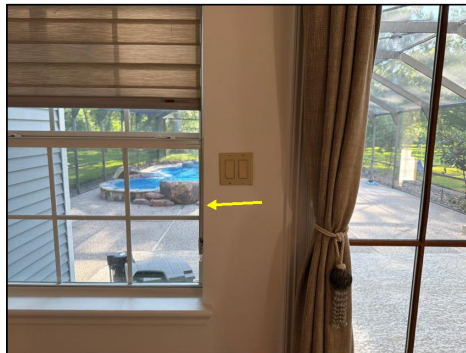
• Electrical switches at multiple areas throughout the home, including the primary bedroom, family room, and dining area, were crooked, uneven, loose, or not flush with the finished wall surfaces and cover plates. Properly align and secure the affected switches, devices, and cover plates and repair adjacent wall finishes as needed to provide stable, complete installations.

Primary bedroom switches observed to be crooked

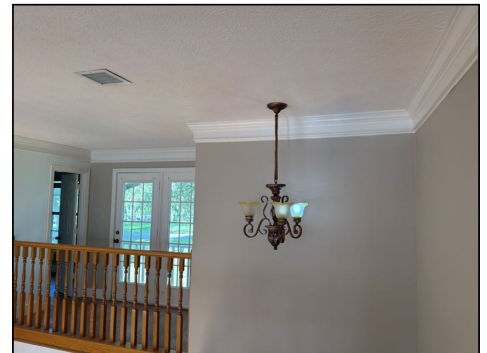
• One or more electrical light fixtures were not operational when tested. The condition may be due to a failed or missing bulb; however, a defective fixture, switch, wiring connection, or other circuit-related issue cannot be ruled out during a visual inspection. Replace the bulb(s) as needed and retest the fixture(s). If operation is not restored, have a qualified electrical professional evaluate the affected fixture(s) and circuit and make repairs as necessary.

Fixture at the stairs did not function properly

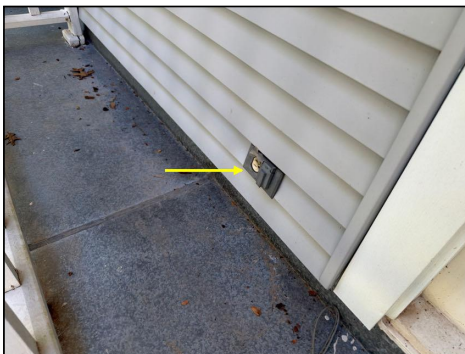
- A damaged/broken exterior electrical outlet cover was observed at the front balcony. Exterior receptacle covers are intended to protect the receptacle and electrical connections from rain, moisture, and other environmental exposure. Replace the damaged cover with a properly rated weather-resistant/in-use cover and verify the receptacle is adequately protected from the elements.

Broken outlet cover noted at the front balcony

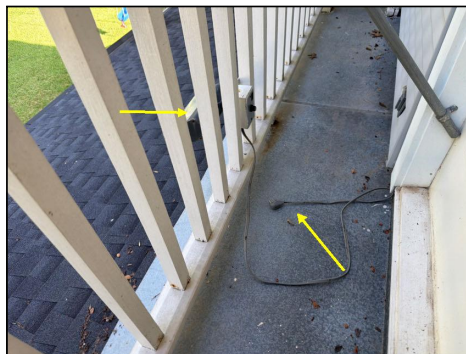
Out of ordinary exterior fixture observed at the front balcony/removed from service

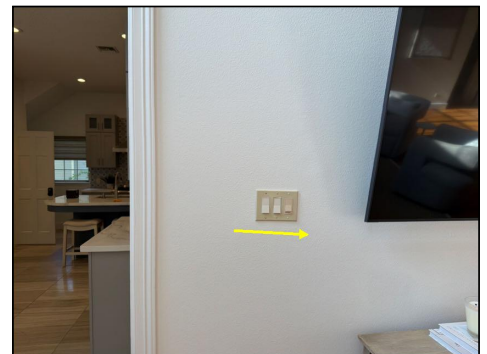
Family room switches observed to be crooked

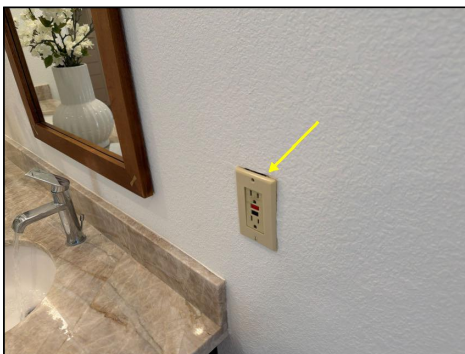
- The electrical receptacle at the primary bathroom wall was observed to be improperly installed and was not seated flush and secure with the finished wall surface. The receptacle cover plate was also missing a mounting screw. Loose or improperly supported electrical devices can allow movement during use, place unnecessary stress on wiring and connections, and leave an incomplete installation. Have a qualified electrical professional properly secure and align the receptacle with the wall surface, install the missing cover plate screw, and verify the device and electrical box are properly installed and secure.

Primary bathroom outlet is not installed properly/loose cover plate

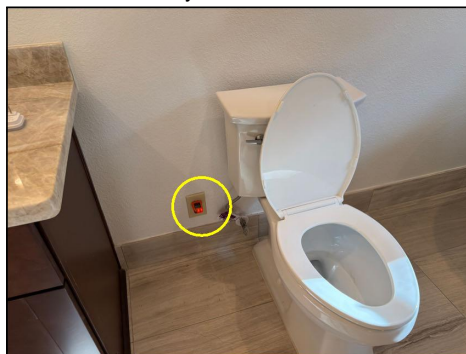
Primary bathroom outlet is not GFCI protected

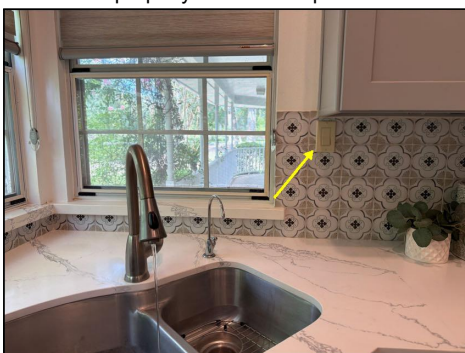
Switch at the kitchen sink noted to be abnormally high

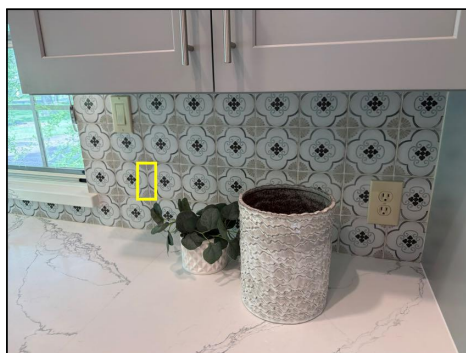
Spacing of the kitchen backsplash outlets does not meet current standards

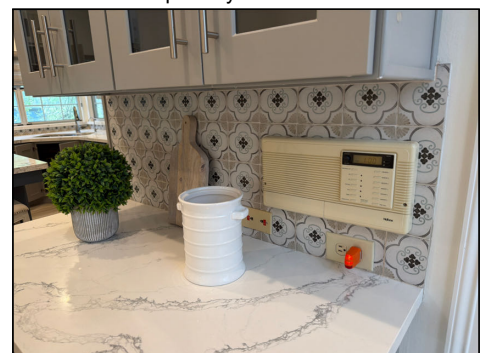
Kitchen backsplash outlet is not GFCI protected/spacing does not meet current standards

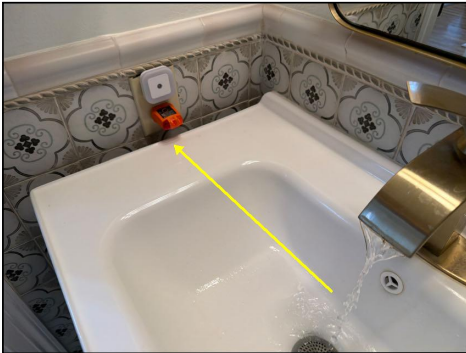
Half bathroom outlet is not GFCI protected

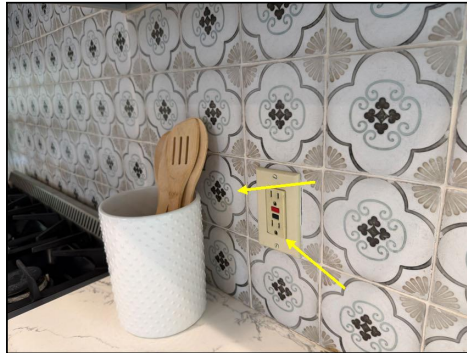
Kitchen backsplash outlet is not installed properly

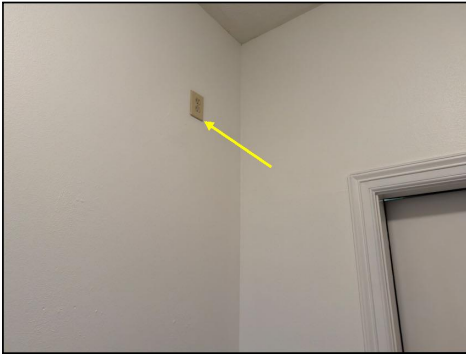
Out of ordinary outlet placement observed in the laundry room

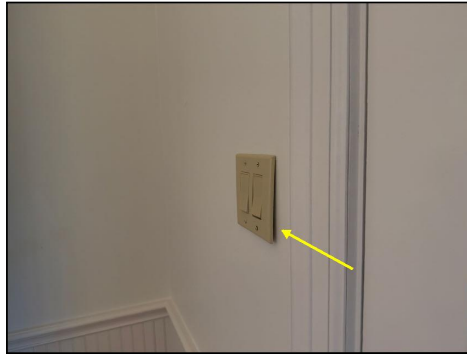
Dining area switches are not flush to the wall

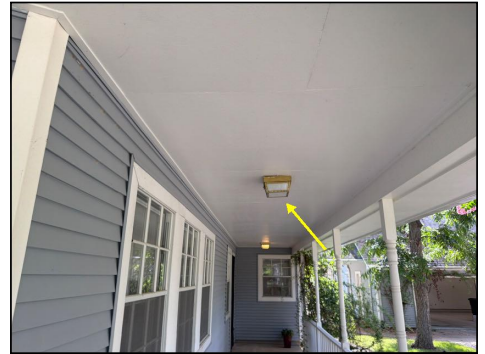
Exterior fixtures did not function at time of inspection

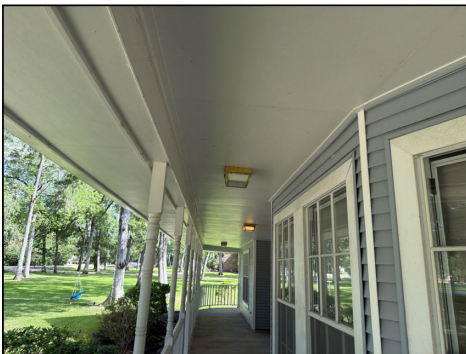
Exterior fixtures did not function at time of inspection

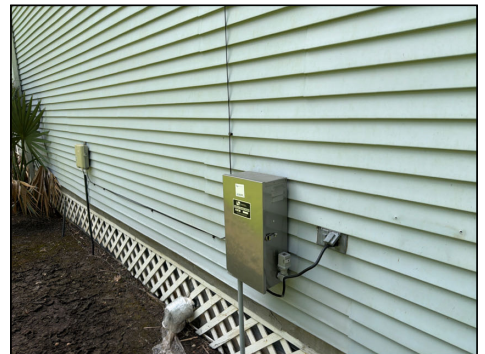
Exterior lighting and timers were not inspected

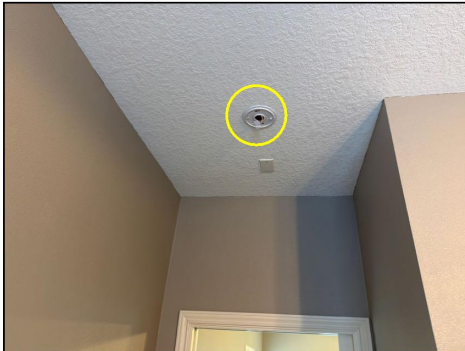
Garage apartment smoke alarm noted to be missing

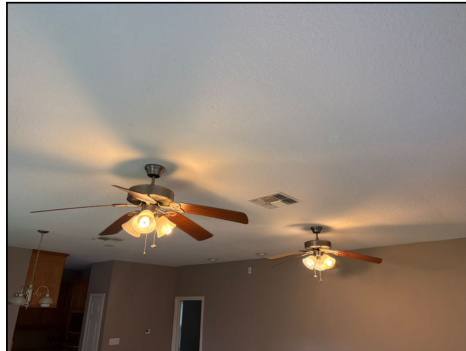
Drooping/weathered ceiling fan blades observed at the garage apartment

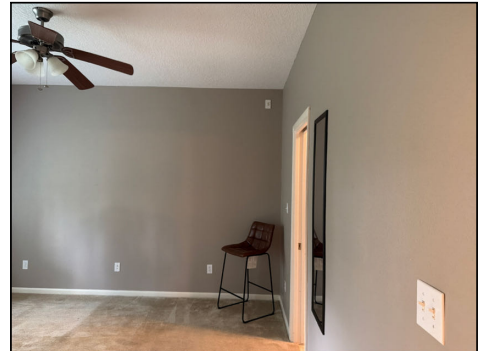
Ceiling fan/light did not function at the garage apartment

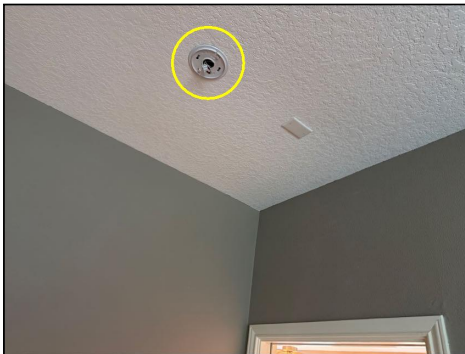
Smoke alarms noted to be missing throughout the garage apartment

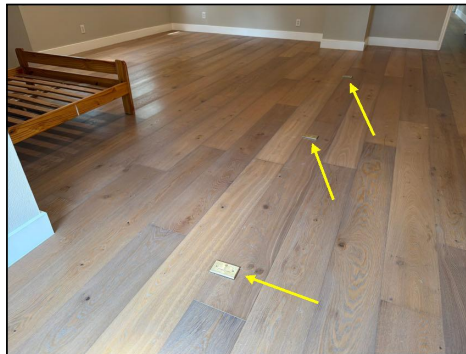
Floor plugs in the right rear game room are not flush to the floor/trip hazards

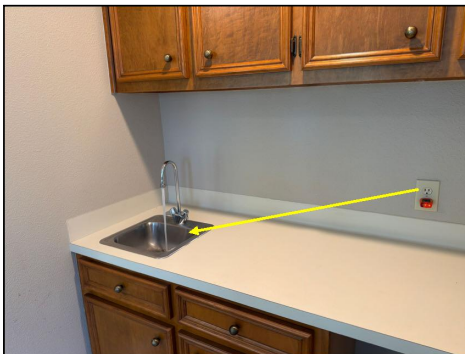
Wet bar outlet is not GFCI protected

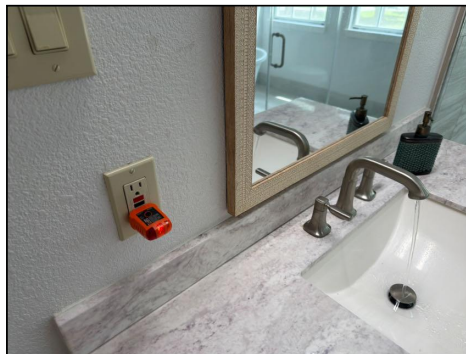
Upstairs right bathroom outlet shows ground reading/not GFCI protected

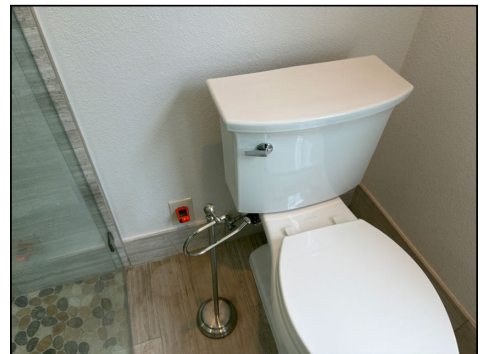
Upstairs right bathroom outlet is not GFCI protected

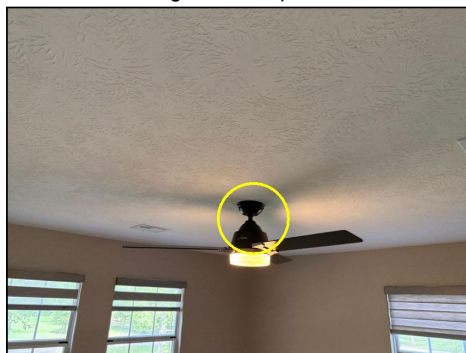
Unnecessary ceiling fan down rod observed in the front left secondary bedroom

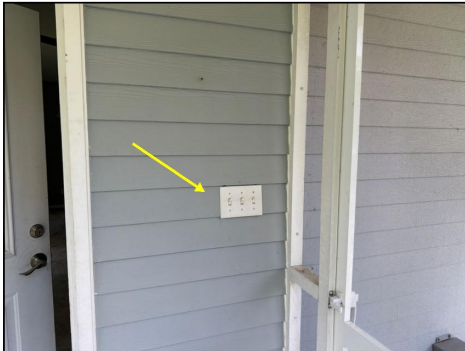
Exterior switch covers noted to be missing at the garage apartment

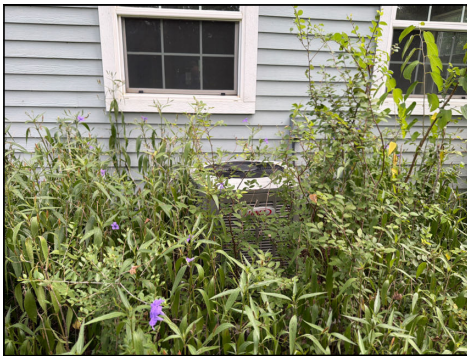
Heavy foliage observed at the garage apartment condenser unit

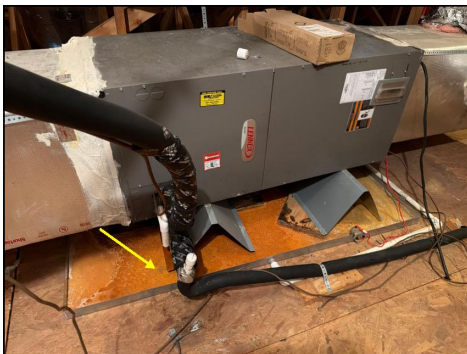
- Evidence of previous secondary condensate-drain activity and rust was present at the garage HVAC overflow pan. Secondary-drain activity indicates that the primary condensate system may have been restricted or unable to carry the full condensate load at some time. Have a qualified HVAC professional clean and test the primary and secondary drain systems, evaluate the rusted pan, and repair or replace affected components as needed.

Evidence of previous secondary drain activity noted at the garage unit/Rusty overflow pan

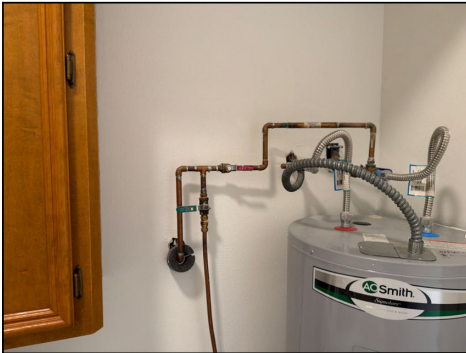
- Copper supply piping observed.
- Multiple unidentified water supply lines and valves were observed at the cold-water piping serving the water heater in the laundry area. One supply line extends into the floor/ground and another extends into the adjacent wall; their destinations and intended functions could not be determined during the inspection. These lines may serve existing or previously installed plumbing fixtures or equipment that were not readily identifiable. The buyer should obtain clarification regarding the purpose and destination of these lines and valves. Any abandoned or no-longer-needed piping should be properly terminated, and the remaining components should be maintained accessible for future service.

Unidentified supply lines observed at the water heater in the laundry area/Likely for water source AC system

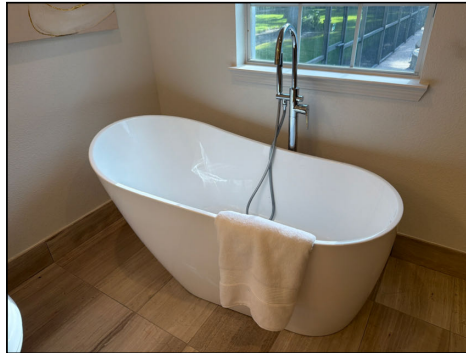
- The freestanding bathtub in the primary bathroom appears to be a replacement installation and was observed to be significantly loose and unsecured to the floor. The tub moved excessively with minimal hand pressure, indicating that it is not adequately anchored or stabilized. Excessive movement can place stress on the tub drain, water-supply connections, floor-mounted plumbing fixture, sealants, and surrounding finishes, potentially resulting in leakage or damage during normal use. Have the bathtub installation evaluated and properly secured/stabilized in accordance with the manufacturer's installation requirements, and verify that the drain and water-supply connections have not been damaged or compromised by the existing movement.

Primary bathtub is not installed properly/easily moves

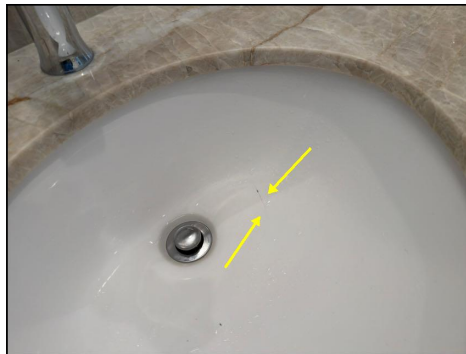
- The front primary bathroom vanity sink bowl was observed to be cracked. Cracks in a sink basin can worsen with continued use and may eventually allow leakage into the vanity cabinet and surrounding materials. Replace the damaged sink bowl and verify the drain, fixture connections, and surrounding installation are watertight after replacement.

Primary vanity sink observed to be damaged/cracked

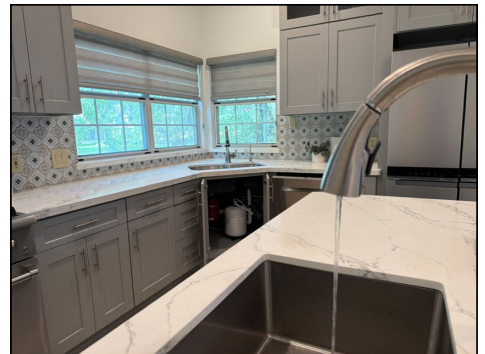
- Low water pressure/flow was observed at multiple plumbing fixtures throughout the home, including the primary bathroom and both kitchen sinks. When multiple fixtures were operated simultaneously, the available flow decreased significantly, with the kitchen sink fixtures becoming borderline nonfunctional due to the reduced water delivery. This condition indicates a broader water-supply limitation rather than an isolated fixture issue and may be related to the water source, pressure-control equipment, filtration/treatment equipment, valves, supply piping, or other components of the plumbing system. Have a qualified plumbing professional evaluate the water-supply system to determine the cause of the inadequate pressure/flow and make repairs or improvements as necessary to provide adequate and consistent water delivery throughout the home.

Low water pressure noted at the fixtures throughout the home

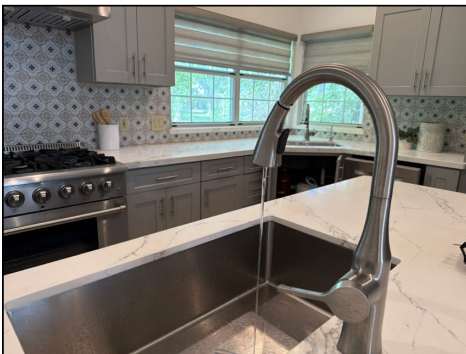
Hot and cold supply reversed at the island sink fixture

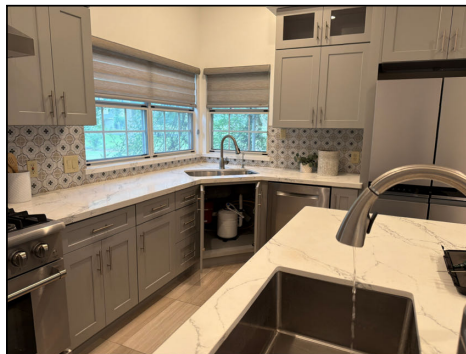
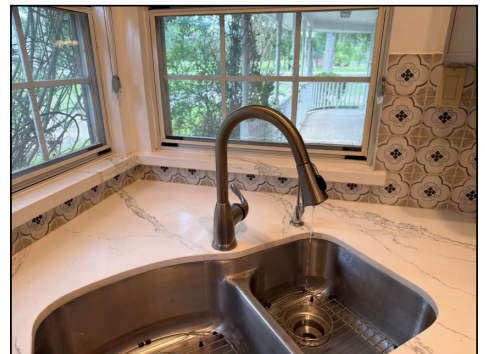
Water pressure down to trickle at some times during inspection

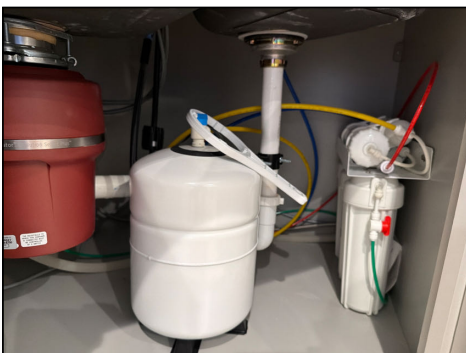
Water filtration system was not inspected

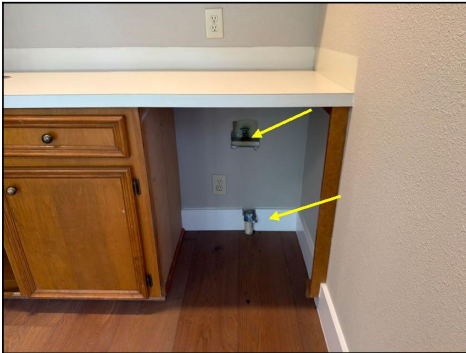
- Water-supply and drain provisions for an ice machine were present at the wet bar. The connections were not tested with an appliance installed. Cap and secure unused connections or verify proper operation and leak-free installation when equipment is connected.

Plumbing for an ice machine noted to be present at the wet bar

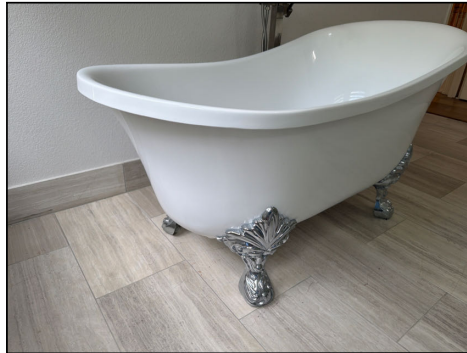
- Multiple plumbing fixtures were loose or inadequately secured, including the upstairs right bathtub, overhead shower supply connection, and vanity faucet. Movement can stress concealed supply and drain connections and result in leakage or finish damage. Properly secure the affected fixtures and verify all connections remain watertight after repairs.

Upstairs right tub is loose at the floor/Easily moves

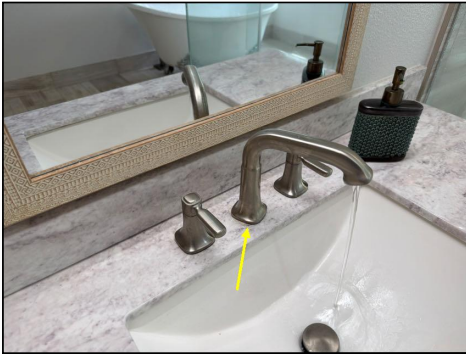
Upstairs, right vanity sink fixture is loose

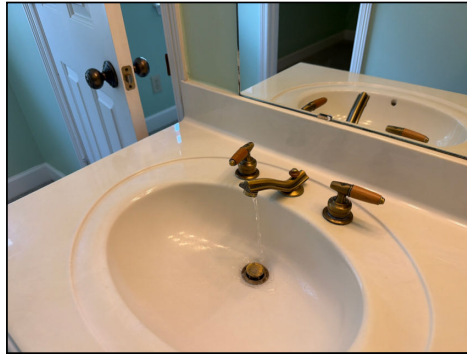
Substandard water pressure noted to be present throughout the home

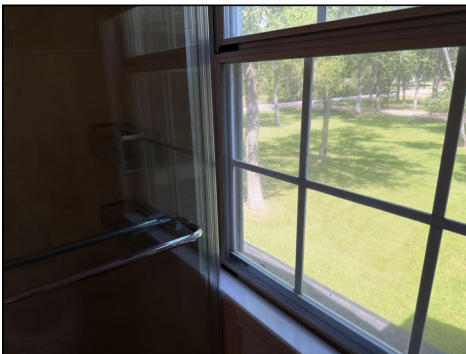
Less than ideal configuration at the left secondary shower surround

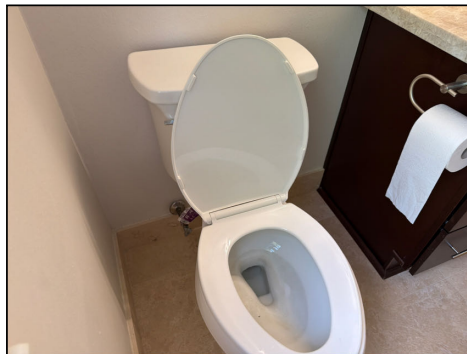
- The upstairs front-left commode filled extremely slowly, and the associated secondary shower had very low flow and did not function properly. These conditions may be related to the broader low-pressure condition or localized restrictions. Have a qualified plumbing professional evaluate the affected supply valves, fixture components, and piping and complete repairs as needed.

Upstairs front left commode was noted to be extremely slow to fill

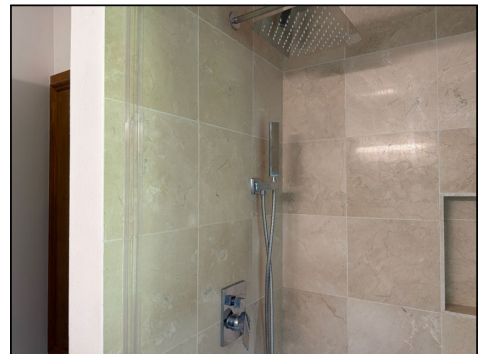
Upstairs front left secondary shower fixture did not function properly/Low pressure

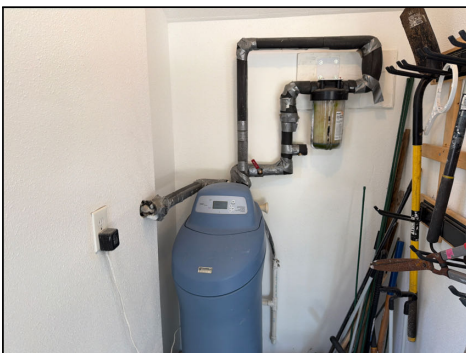
Water softening system was not inspected

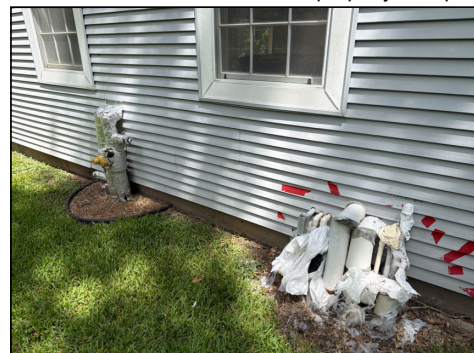
- Deteriorated or missing insulation was observed on exposed water-supply piping at the right side of the garage. Replace and secure suitable insulation to protect the piping from temperature changes, condensation, and freezing conditions.

Deteriorated insulation observed on the right side of the garage

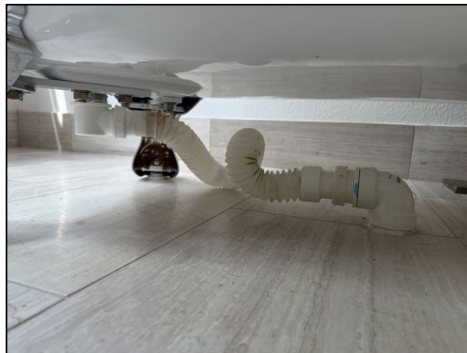
- The upstairs-right bathtub drain was improperly configured using an improvised assembly with flexible/corrugated piping, multiple slip-joint connections, and poorly aligned components. This is not an acceptable permanent drain installation and is more susceptible to movement, separation, leakage, restricted drainage, and recurring clogs. Have a qualified plumbing professional remove the improper components and install a properly sized, supported, smooth-wall drain and trap assembly, then verify the completed installation is properly vented and leak-free.

Amateur/improper drain installation at the upstairs right tub

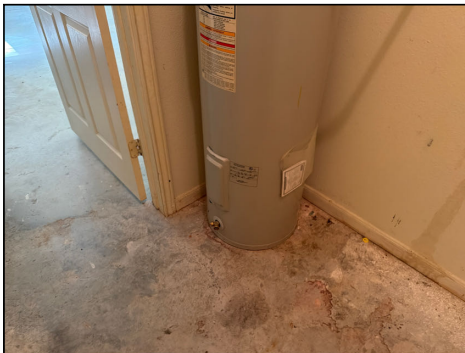
Overflow pan/drain line noted to be missing at the garage apartment unit

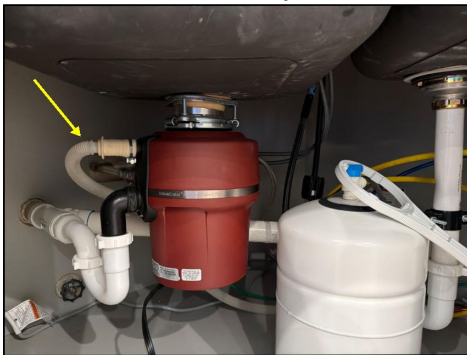
- Dishwasher appeared to operate as intended.
- No air gap is present, raise drain line above bottom of kitchen sink or install counter mount air gap device.
- The garage-apartment dishwasher was not installed square and aligned within the cabinet opening. Adjust and secure the appliance to the countertop or adjacent cabinetry as required, provide uniform clearances, and verify the door operates without binding and the supply and drain connections remain leak-free.

Air gap is missing at the dishwasher drain

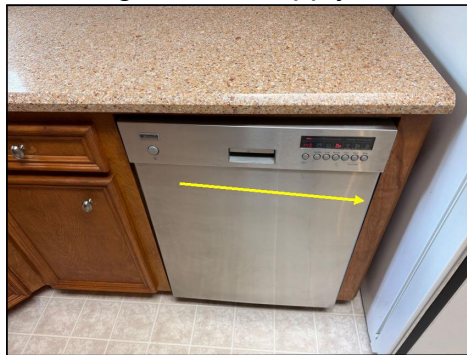
Garage apartment dishwasher is not installed square to opening

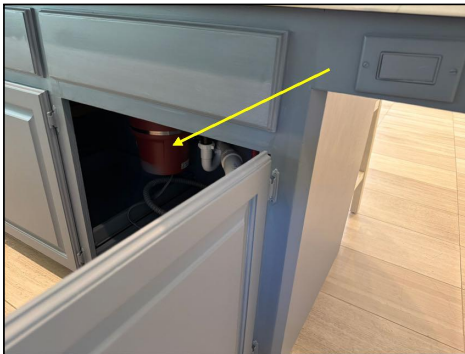
Disposal switch noted to be right of the island sink

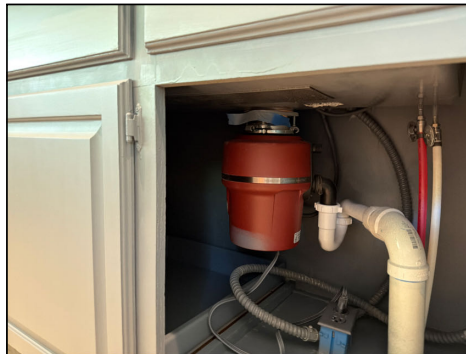
Island disposal did not function at time of inspection/jammed

- The island food-waste disposer was jammed and did not operate when tested. Have the unit cleared and serviced or replaced, and verify the mounting, electrical connection, and drain connections are secure and leak-free.
- Food-waste disposers were installed at the main kitchen and garage apartment even though the property is served by a private septic system. Disposers can increase solids and organic loading on a septic system and may require more frequent maintenance. Use the disposers sparingly and consult the septic-service provider regarding appropriate operation and pumping intervals.

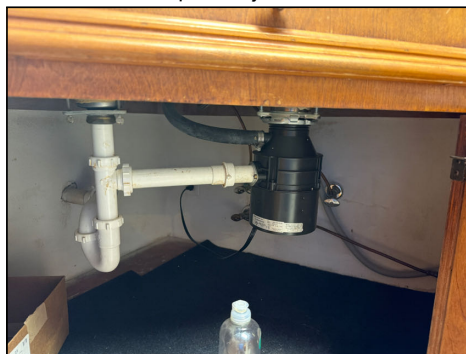
Disposal noted to be present at the garage apartment/typically not found with septic systems

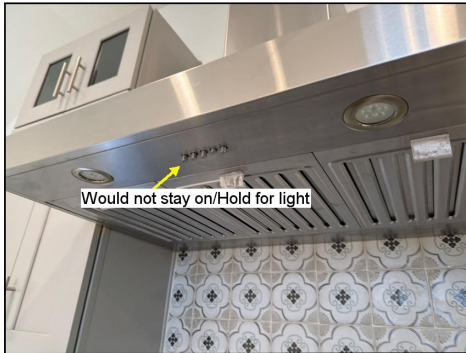
Button for the vent hood light did not function properly

- The unit appears to be performing as intended.
- The vent hood light control was not functioning properly when tested. The lights illuminated only while the control button was actively depressed and immediately turned off when the button was released, indicating a defective or malfunctioning switch/control mechanism. Repair or replace the affected control or vent hood components as needed to restore normal operation of the lighting.
- The garage-apartment range-hood/exhaust unit was excessively noisy when operated. Have the fan, motor, mounting, and duct connection evaluated and repair or replace worn or loose components as needed.

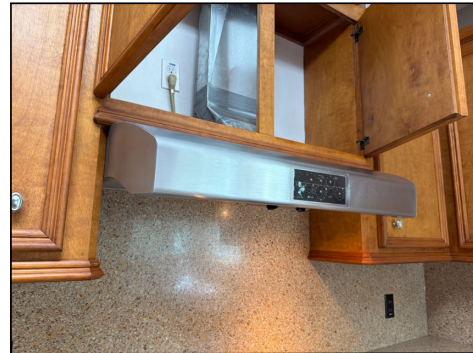
Garage apartment unit noted to be extremely noisy

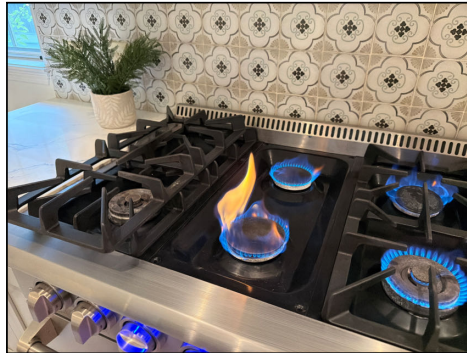
Range burners did not function properly/Did not appear to sit correctly

- Unit(s) appeared to operate as intended.
- Multiple gas range burners were not functioning properly when tested. Several burners failed to ignite reliably and produced excessive, irregular orange flames, including abnormal flame flare-up during attempted operation. Improper ignition and abnormal flame characteristics can indicate dirty or obstructed burner components, improperly seated burner caps, incorrect air/fuel mixture, gas-pressure issues, defective ignition components, or other problems requiring service. Due to the abnormal ignition and flame behavior, further operation is not recommended until the range has been evaluated. Have a qualified appliance service professional evaluate, clean, adjust, and repair the range as needed to provide reliable ignition and a stable, properly controlled burner flame.

| Page 51 Item: D | Ranges, Cooktops, and Ovens | <ul style="list-style-type: none"><li>• Multiple gas range burners were not functioning properly when tested. Several burners failed to ignite reliably and produced excessive, irregular orange flames, including abnormal flame flare-up during attempted operation. Improper ignition and abnormal flame characteristics can indicate dirty or obstructed burner components, improperly seated burner caps, incorrect air/fuel mixture, gas-pressure issues, defective ignition components, or other problems requiring service. Due to the abnormal ignition and flame behavior, further operation is not recommended until the range has been evaluated. Have a qualified appliance service professional evaluate, clean, adjust, and repair the range as needed to provide reliable ignition and a stable, properly controlled burner flame.</li></ul> |

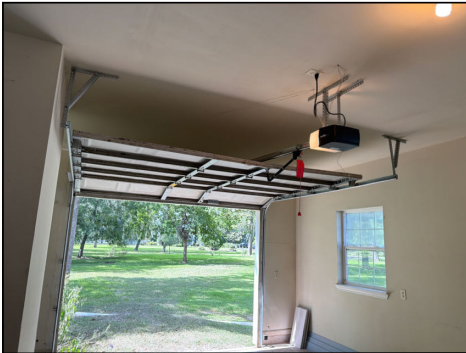
Rear door opener did not function properly/button had to be held to close

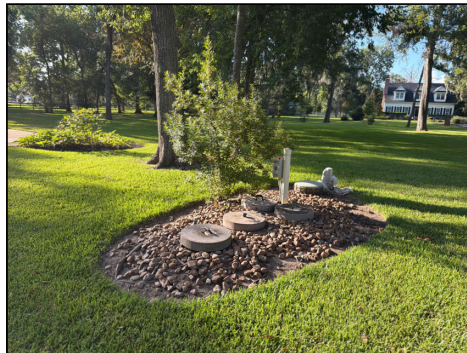
Septic equipment observed on the right side of the property

- Area around septic tank appeared normal, no leaking was visible
- Recommend inspection by septic tank company
