# Property Inspection Report

Sample Property - Richmond, TX

Date of Inspection: 8/9/2026 Time: 9:00 AM

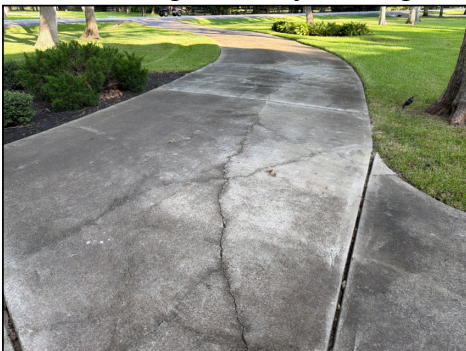
• Multiple sections of the concrete driveway were observed to be cracked and/or broken. Cracking and deterioration of exterior concrete flatwork commonly develop over time due to normal concrete shrinkage, soil movement, settlement, vehicle loading, and environmental exposure. Although some cracking is typical for flatwork of this age, broken or displaced sections can continue to deteriorate and may result in uneven walking or driving surfaces. Repair or replacement of significantly damaged sections is recommended as desired.

Multiple sections of the driveway observed to be cracked/broken

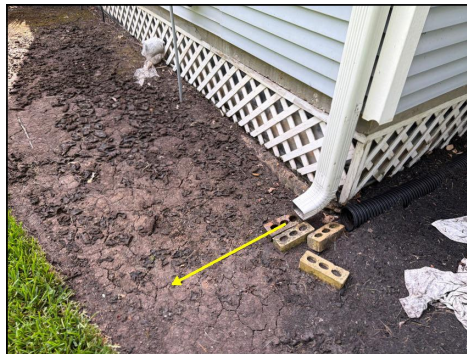
Gutter extensions are recommended

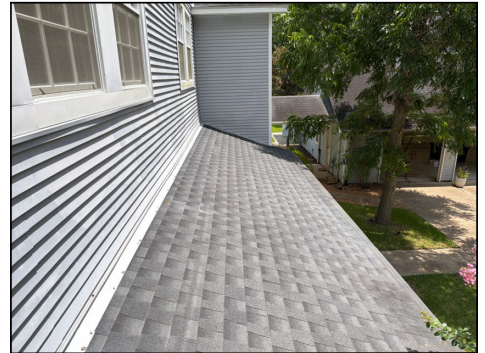
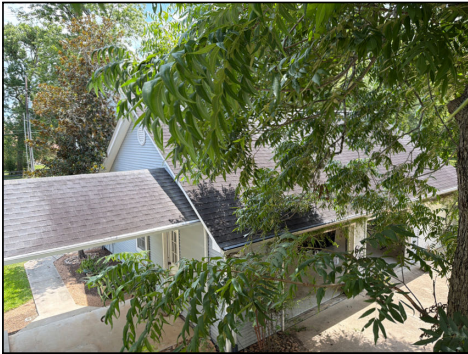
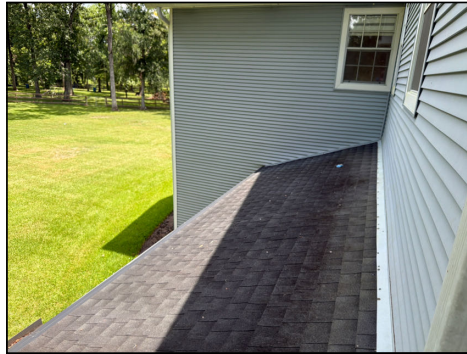
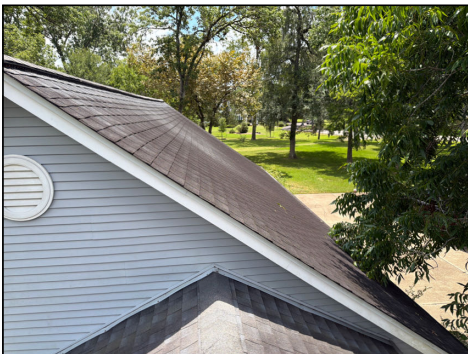
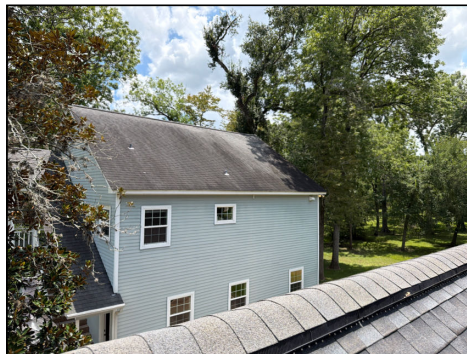
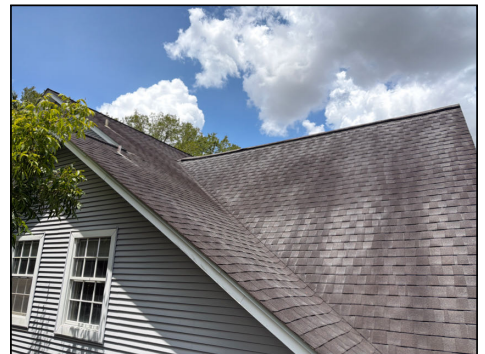
Roofing materials appeared to be performing as intended

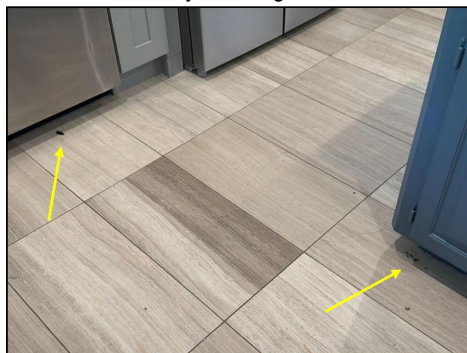
Pest remains were observed throughout the home

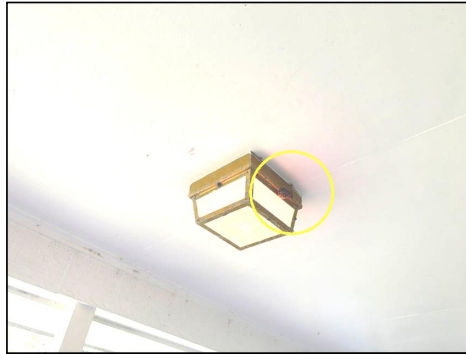
Active paper wasps observed on the left side of the home

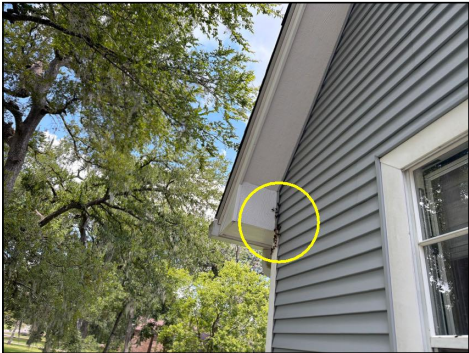
Aggressive paper wasps observed at the front left of the home/Inspector was stung walking the roof

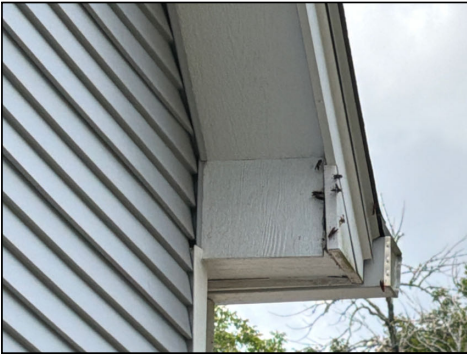
Active paper wasps observed at the left rear of the home

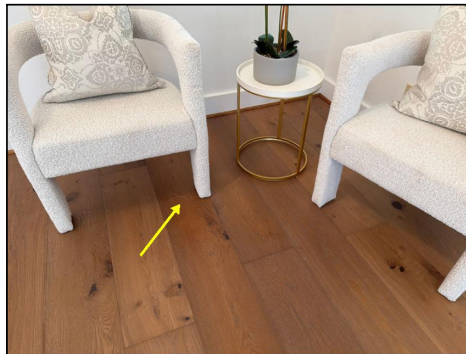
- Damage, scratches, and surface wear were observed at the primary bedroom flooring. Repair, refinish, or replace the affected flooring as desired to restore the appearance and help prevent further deterioration of the damaged finish.

Scratches observed in the primary bedroom throughout

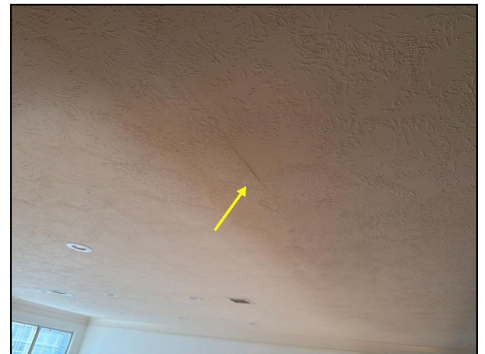
- Typical drywall cracking and visible tape/seam separation were observed at portions of the ceilings. These conditions commonly develop over time as the home experiences normal settlement, seasonal movement, and expansion and contraction of framing and finish materials. The observed conditions appeared cosmetic in nature at the time of inspection. Repair loose or separated tape, cracks, and affected finishes as desired, and monitor repaired areas for significant recurrence or continued movement that could warrant further evaluation.

Damaged drywall/cracked seam observed at the family room ceiling

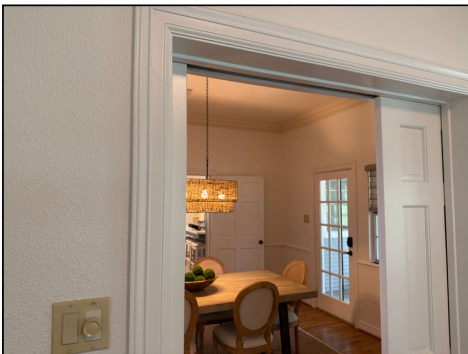
- The pocket doors at the formal living and dining room were difficult to operate and required excessive effort to fully close. When closed, the doors did not align evenly with one another and an inconsistent reveal was present from the top to the bottom where the doors meet. This condition may be related to adjustment of the door hardware, worn or damaged rollers/tracks, or movement/misalignment of the door assemblies over time. Have the pocket door assemblies evaluated and adjusted or repaired as needed to provide smooth operation, proper alignment, and a consistent finished appearance when closed.

Formal living to dining room pocket doors difficult to operate

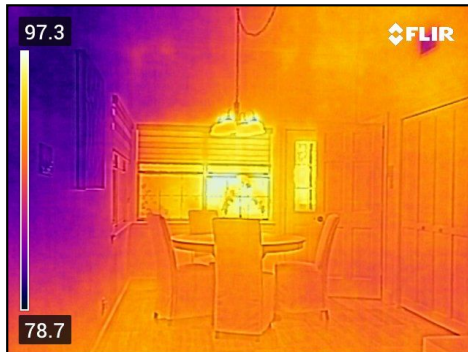
No major thermal anomalies were observed with IR camera scan of the home

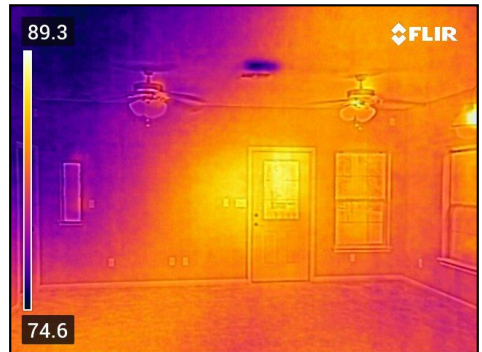
No major thermal anomalies were observed with IR camera scan of the home

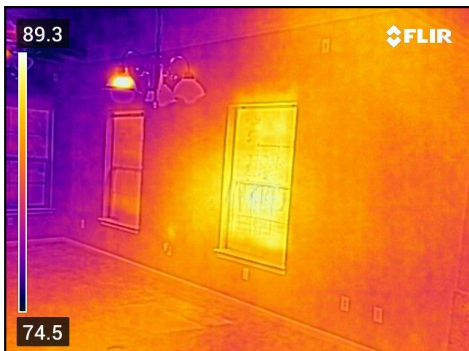
No major thermal anomalies were observed with IR camera scan of the home

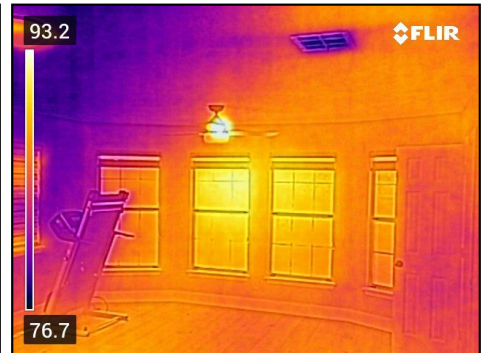
No major thermal anomalies were observed with IR camera scan of the home

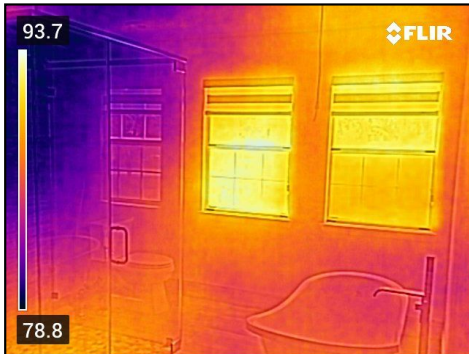
No major thermal anomalies were observed with IR camera scan of the home

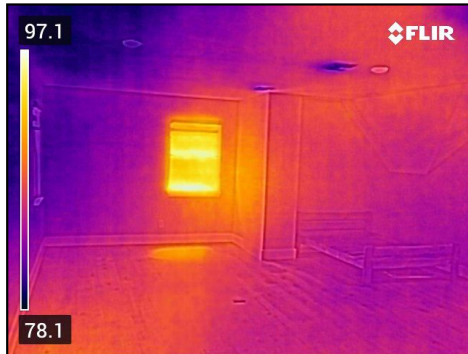
No major thermal anomalies were observed with IR camera scan of the home

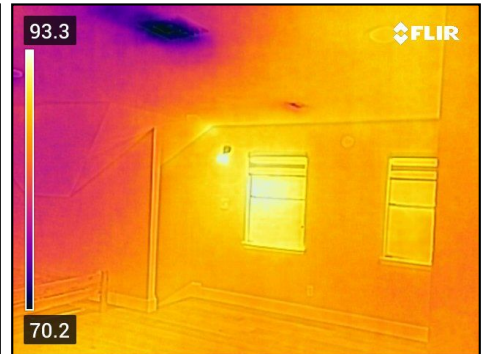
No major thermal anomalies were observed with IR camera scan of the home

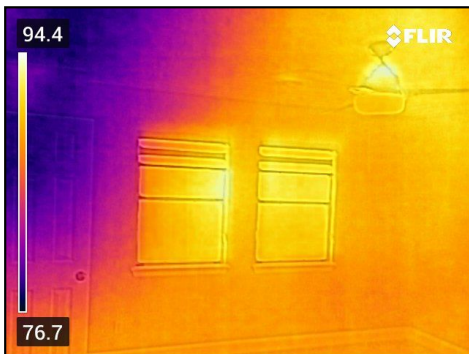
No major thermal anomalies were observed with IR camera scan of the home

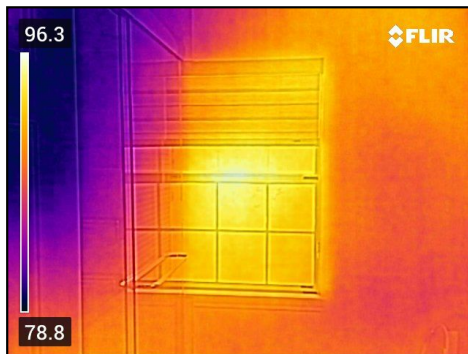
No major thermal anomalies were observed with IR camera scan of the home

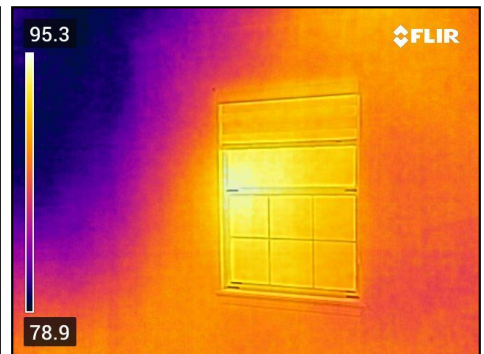
No major thermal anomalies were observed with IR camera scan of the home

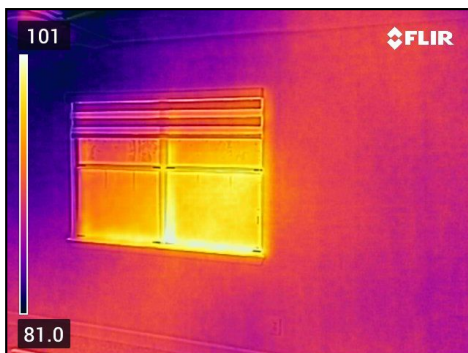
No major thermal anomalies were observed with IR camera scan of the home

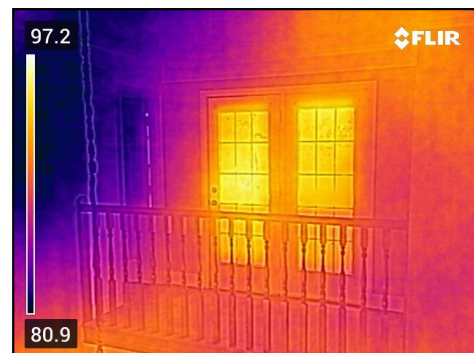
No major thermal anomalies were observed with IR camera scan of the home

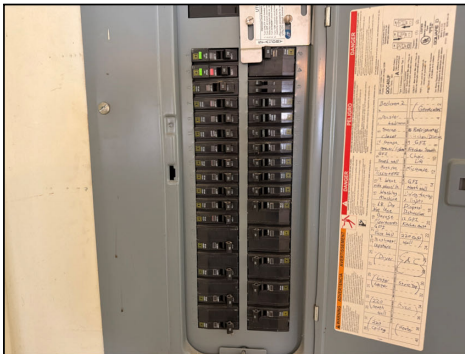
AFCI breakers were not present

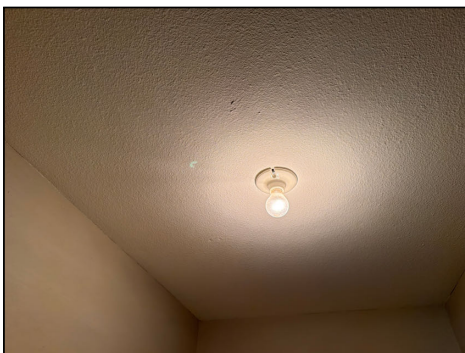
Current standards require globes on closet fixtures

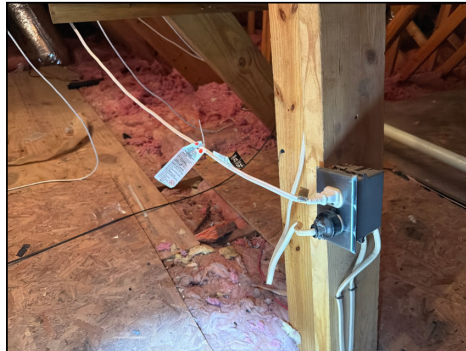
Extension cord used as permanent wiring in the attic

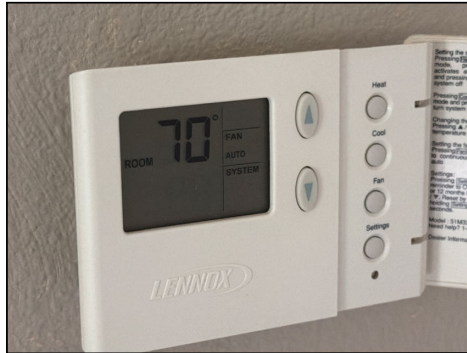
• The heating system serving the garage apartment did not operate when tested from the thermostat. The cause could not be determined during this inspection. Have a qualified HVAC professional diagnose the system and complete repairs before relying on it for heating.

Furnace at the garage apartment unit did not function at the time of inspection

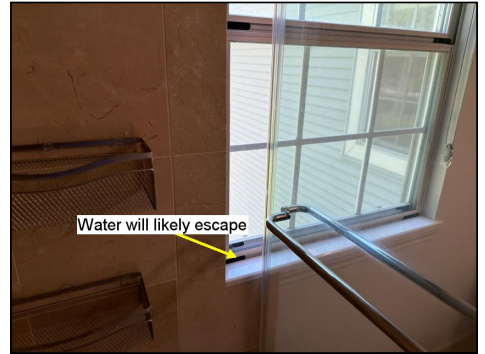
Less than ideal configuration at the left secondary shower surround

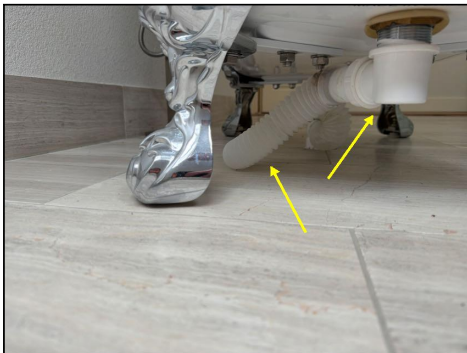
- The upstairs-right bathtub drain was improperly configured using an improvised assembly with flexible/corrugated piping, multiple slip-joint connections, and poorly aligned components. This is not an acceptable permanent drain installation and is more susceptible to movement, separation, leakage, restricted drainage, and recurring clogs. Have a qualified plumbing professional remove the improper components and install a properly sized, supported, smooth-wall drain and trap assembly, then verify the completed installation is properly vented and leak-free.

Amateur/improper drain installation at the upstairs right tub

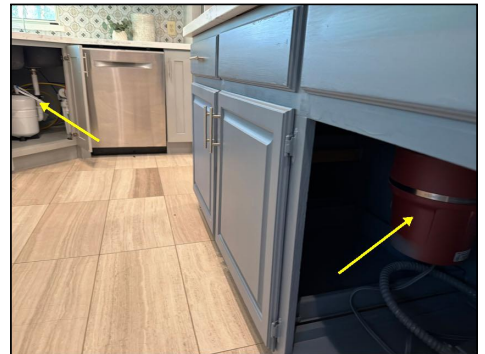
Disposals are typically not present with septic systems

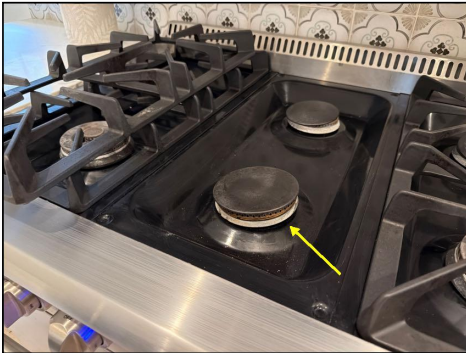
Range burners did not function properly/Did not appear to sit correctly

- Unit(s) appeared to operate as intended.
- Multiple gas range burners were not functioning properly when tested. Several burners failed to ignite reliably and produced excessive, irregular orange flames, including abnormal flame flare-up during attempted operation. Improper ignition and abnormal flame characteristics can indicate dirty or obstructed burner components, improperly seated burner caps, incorrect air/fuel mixture, gas-pressure issues, defective ignition components, or other problems requiring service. Due to the abnormal ignition and flame behavior, further operation is not recommended until the range has been evaluated. Have a qualified appliance service professional evaluate, clean, adjust, and repair the range as needed to provide reliable ignition and a stable, properly controlled burner flame.

| Page 51 Item: D | Ranges, Cooktops, and Ovens | <ul style="list-style-type: none"><li>• Multiple gas range burners were not functioning properly when tested. Several burners failed to ignite reliably and produced excessive, irregular orange flames, including abnormal flame flare-up during attempted operation. Improper ignition and abnormal flame characteristics can indicate dirty or obstructed burner components, improperly seated burner caps, incorrect air/fuel mixture, gas-pressure issues, defective ignition components, or other problems requiring service. Due to the abnormal ignition and flame behavior, further operation is not recommended until the range has been evaluated. Have a qualified appliance service professional evaluate, clean, adjust, and repair the range as needed to provide reliable ignition and a stable, properly controlled burner flame.</li></ul> |

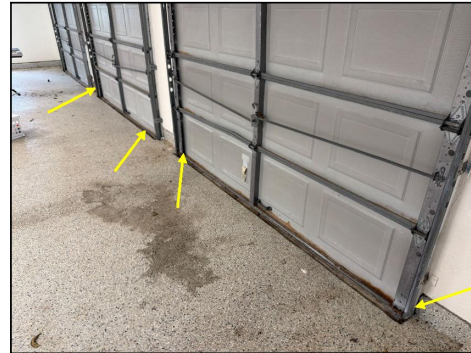
Reverse sensors were not present

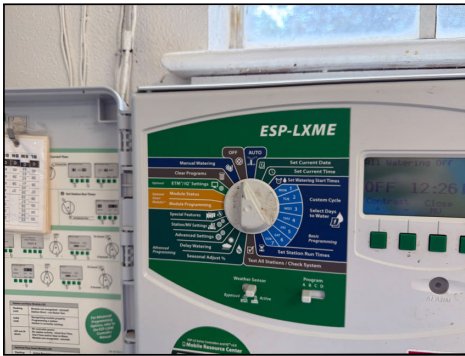
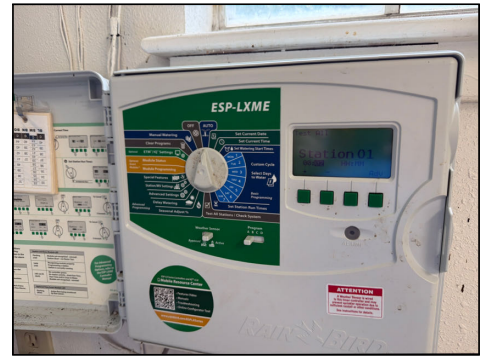
System was off upon arrival/Did not function when attempted

• The landscape-irrigation controller was off upon arrival and the system did not operate when activation was attempted. The controller indicated approximately 31 zones. Because the zones could not be operated, sprinkler heads, valves, coverage, leaks, and backflow components were not functionally evaluated. Have a qualified irrigation professional diagnose the system, restore operation, and test all zones and safety components.

| Page 55 Item: A | Landscape Irrigation (Sprinkler) Systems | <ul style="list-style-type: none"><li>• The landscape-irrigation controller was off upon arrival and the system did not operate when activation was attempted. The controller indicated approximately 31 zones. Because the zones could not be operated, sprinkler heads, valves, coverage, leaks, and backflow components were not functionally evaluated. Have a qualified irrigation professional diagnose the system, restore operation, and test all zones and safety components.</li></ul> |

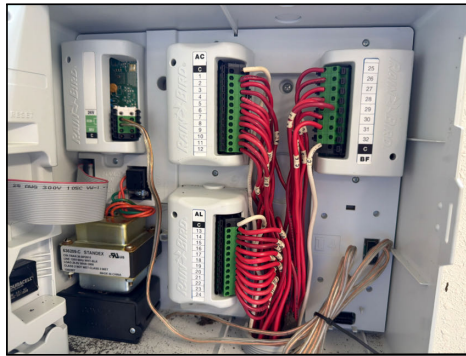
31 zones appeared to be present

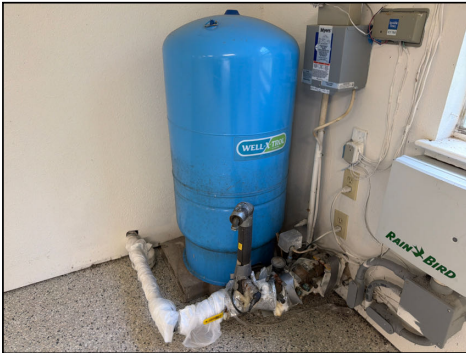
Well should be further evaluated for low pressure

• The private well pressure gauge indicated approximately 50 PSI; however, inadequate water pressure and flow were present at fixtures throughout the home and garage apartment, with flow dropping substantially when multiple fixtures were used. The static gauge reading does not confirm adequate delivery volume under demand. Have a qualified well and plumbing professional evaluate the pump, pressure tank, pressure switch, filtration/treatment equipment, valves, supply piping, and available flow rate under load and complete repairs or improvements as necessary.

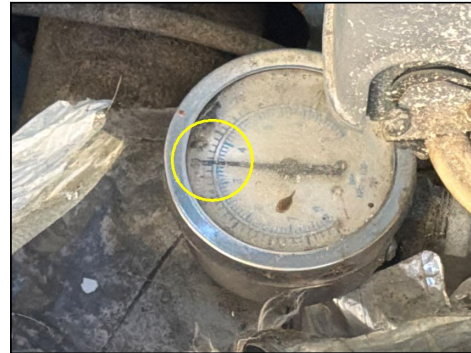
Well showed 50 PSI
